The 1762 Akin House Photo Report of the Cellar Water/Moisture Mitigation Project CPA Project Grant Agreement: 2025-10-01

Prepared by Diane Gilbert, President, DHPT, April 28, 2026, revised May 3, 2026.

The 1762 Akin House: photos of the water/moisture mitigation project.

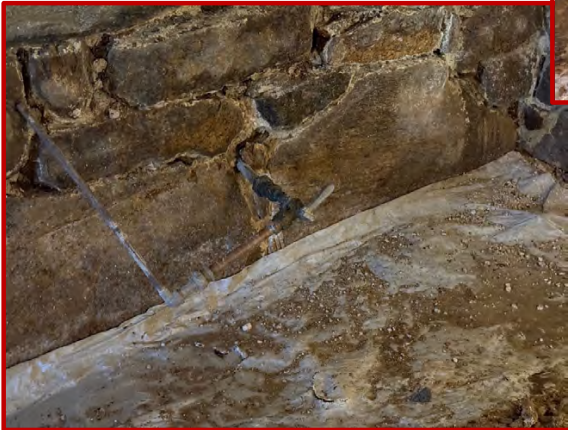
Left: View of the northwest corner of the cellar.

Due to heavy rains and the highwater table, photos show evidence of water pooling on top of the old vapor barrier before the work started. A layer of clay of unknown depth was discovered below the two feet + of soils and stones. This explains the difficulty to achieve the proper drainage for the property/house. This issue is endemic to this area.

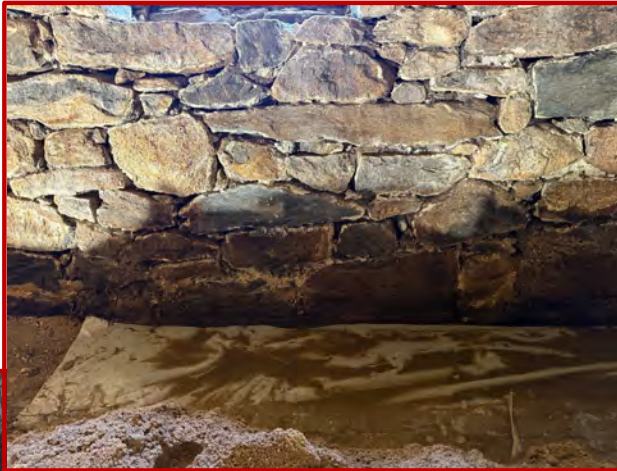
Middle: Foundation wall at the center of the west elevation.

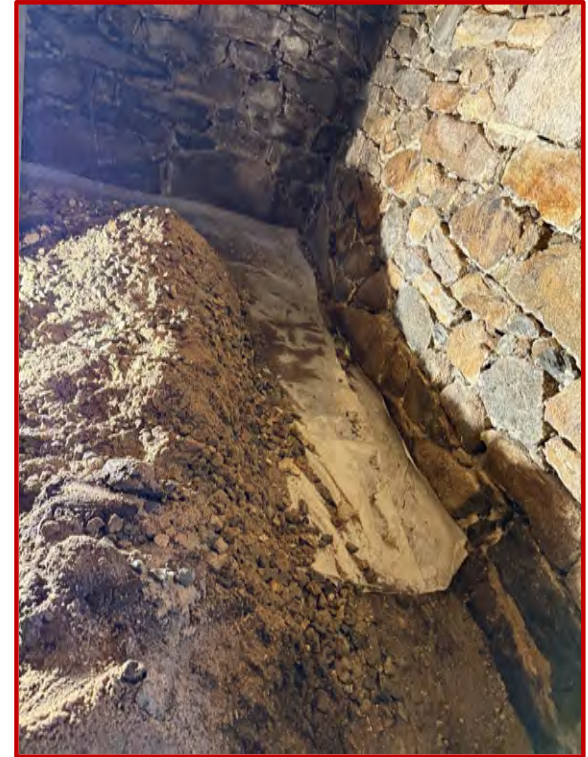
Right: Northeast corner of the cellar showing prep work, e.g., digging the French Drain, two feet deep from the floor.

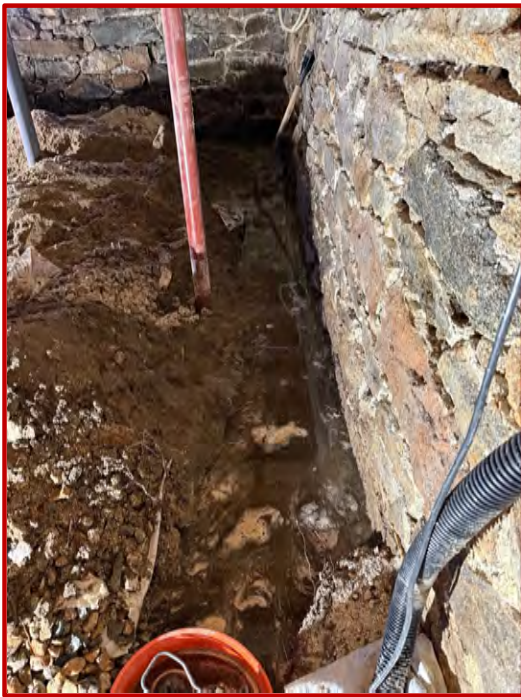
March 25, 2026 conditions as work began. Left: Northeast corner, showing steel columns to support the house from the foundation up. Middle: View from east elevation entrance with southwest corner in the background showing the elevated feature. Note green mold on the far wall. Right: Northwest corner. Water damage and damp conditions in evidence throughout.

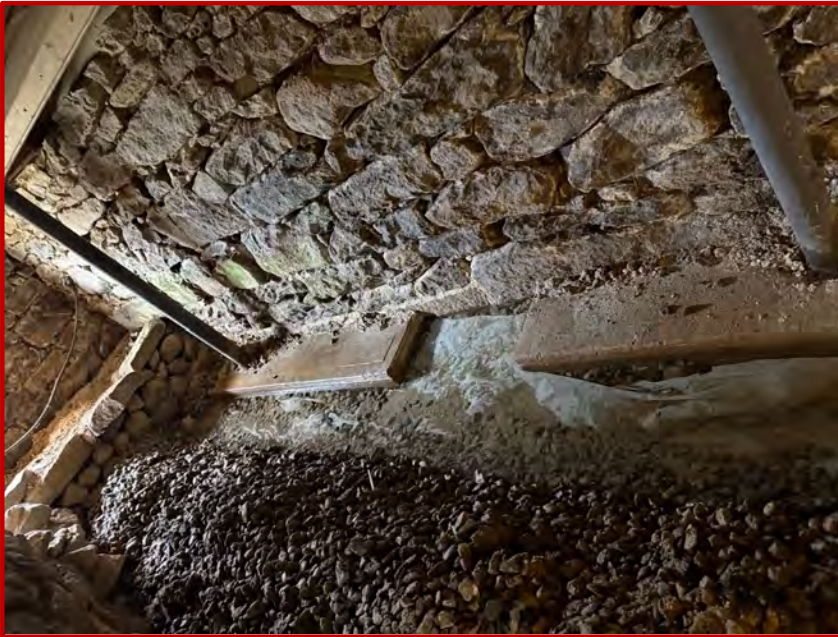
March 25, 2026 conditions as work began. Left: Stone foundation at the far west wall, near a special feature at the far left. Note the steel columns on cement pads supporting new beams to stabilize the building. This work was performed during Phase 2 (2009-2010). Right: A close-up view of the northwest corner showing a terminated water pipe leading to Dartmouth Street. A lead pipe from the house to the street prohibits the reintroduction of water. The town should consider installing a copper or PVC pipe in the future to allow water use at the property.

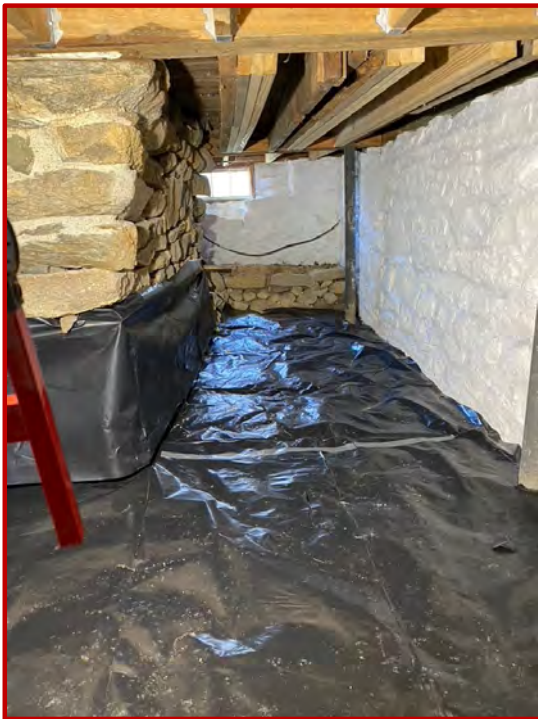
April 9, 2026: Following the installation of the French Drain and the application of several coats of Masonry Sealer, the cellar is prepped for the cement floor on top of a new vapor barrier, which will also cover the French Drain at the perimeter

Far left: The vapor barrier surrounding the center chimney foundation is protected from splatter during the project steps. The very old electric wire at the far center of the photo is "dead" and will be removed. Second from left: Photo shows two supporting steel columns and a cement sphere to remain in situ. Second from right: A terra cotta repository to accept and redirect water from the French Drain system to the sump pump. Far right: Cement pour.

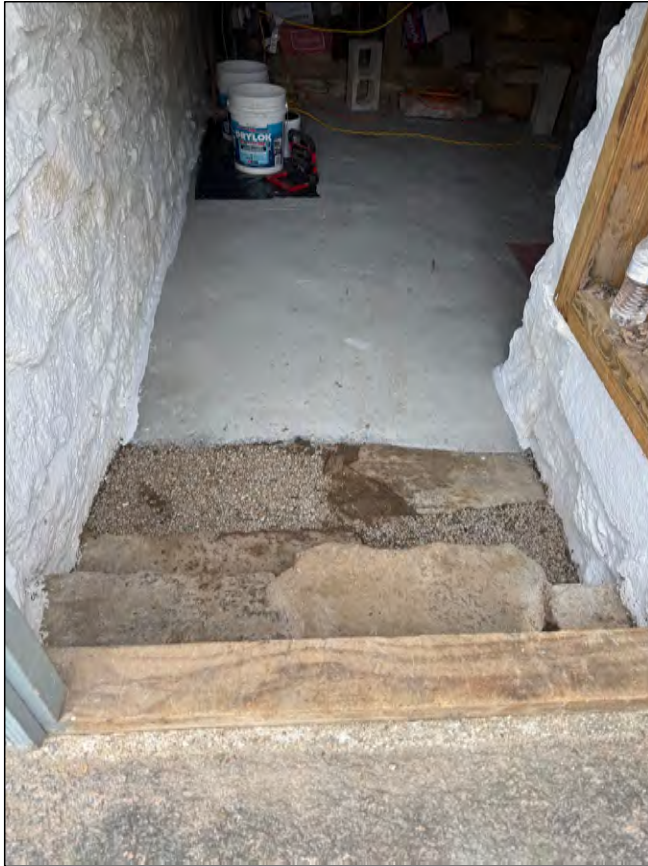
Left: Cellar entrance from the east elevation.

Another masonry sealer coat is underway, hence the protecting red plastic, etc.

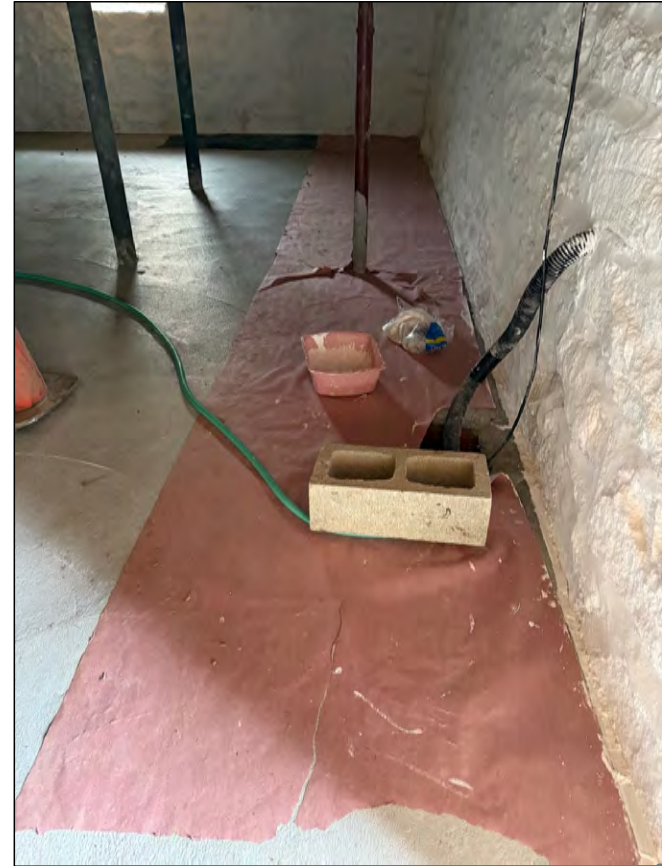
Right: Area to the right of the cellar entrance where the French Drain connects to the sump pump. The northeast corner of the cellar is in the background showing the stabilizing steel columns.

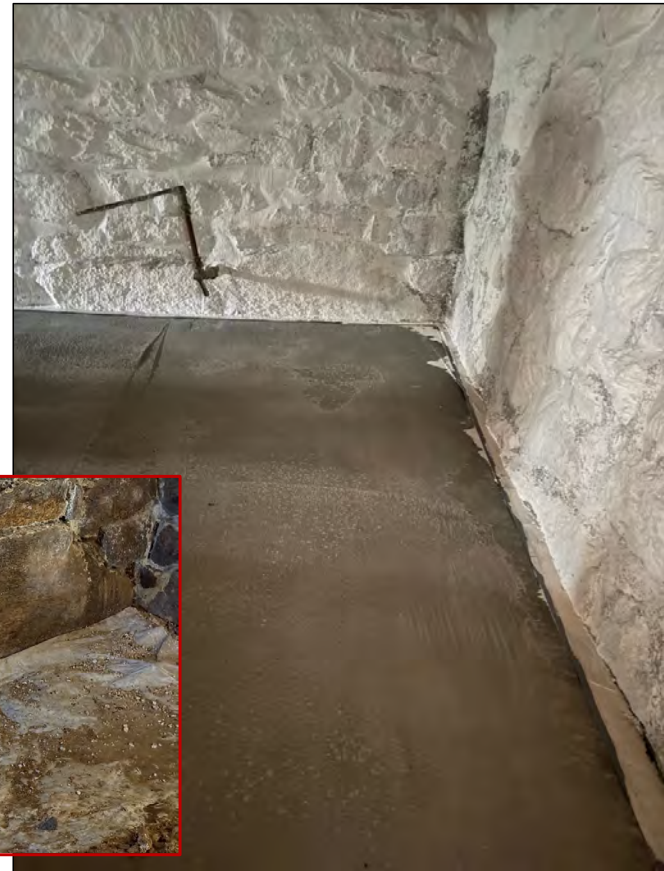
Right: Northwest corner of the cellar.

Note: The terminated pipe is a water source from Dartmouth Street to the cellar.

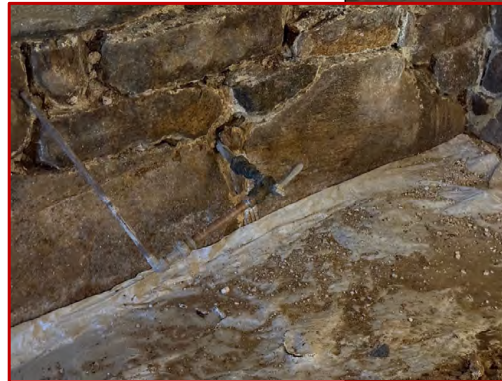
Below right: "Before" photo also showing the water pipe.

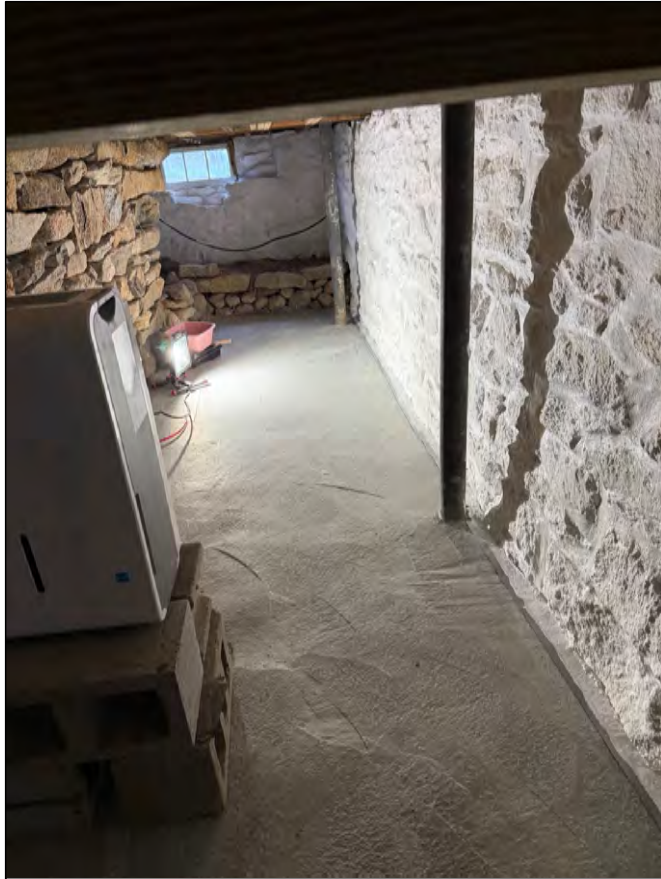
Left: The west wall of the cellar, with chimney foundation to the left; the dehumidifier in foreground left; a unique stone feature can be seen on the far south side beneath the cellar window.

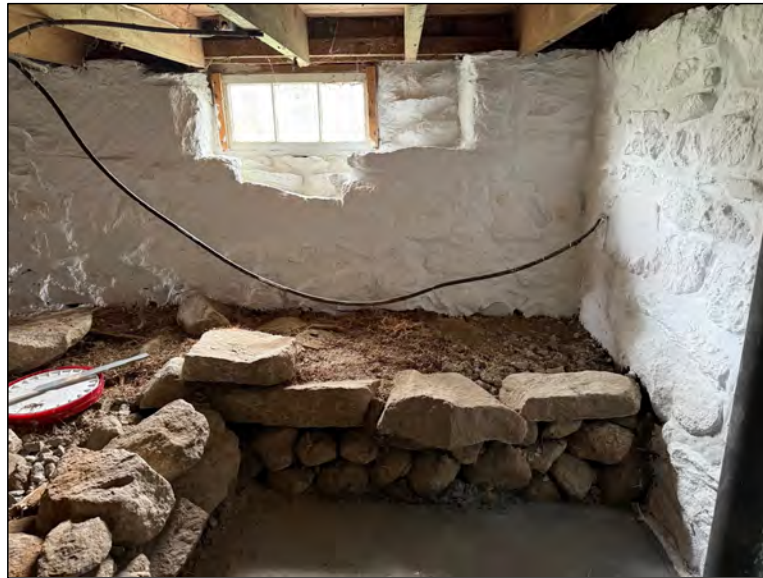
Right: Close-up of the early stone feature about 18 inches high, presumably used for storage to protect house-hold materials in the event of cellar flooding. An example of the early methods used to manage intermittent flooding. The “dead” electric wire connected to nothing “live” from the circa late 19th-20th century will be removed.

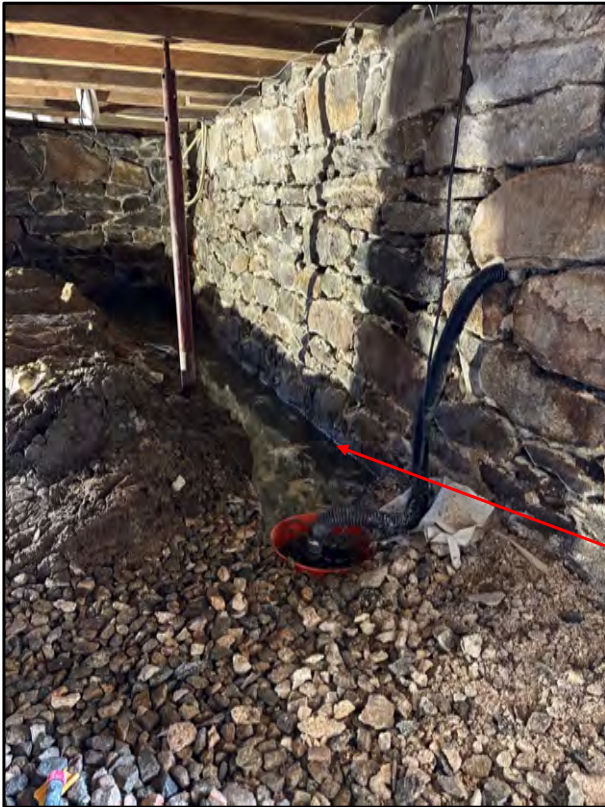
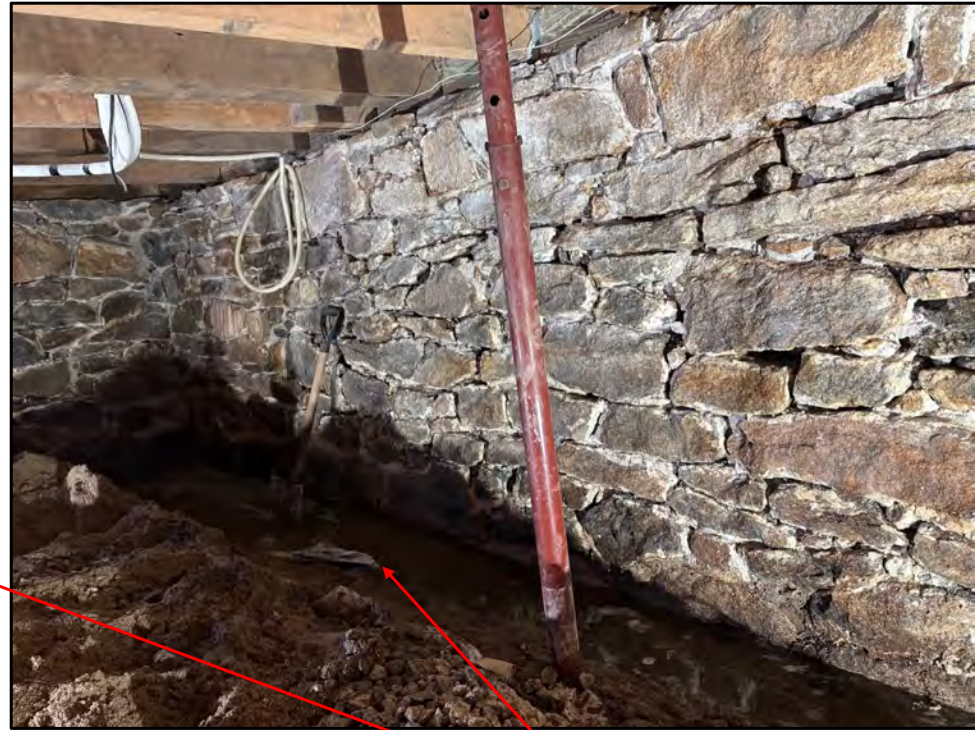
March 25, 2026: additional photos of the French Drain installation. The team had difficulty keeping up with the water while digging two feet.
