Mystery Solved!

September's CPWP 'Plaster Bits' generated a lot of hypotheses on what this "new" and obviously interesting wall decoration at the Dartmouth, MA Heritage Preservation Trust's Akin House could possibly be. It was decidedly early, since it was applied directly on the vertical boards then covered with many layers of local newspaper and wall paper, each denoting a different time and expression of home decoration.

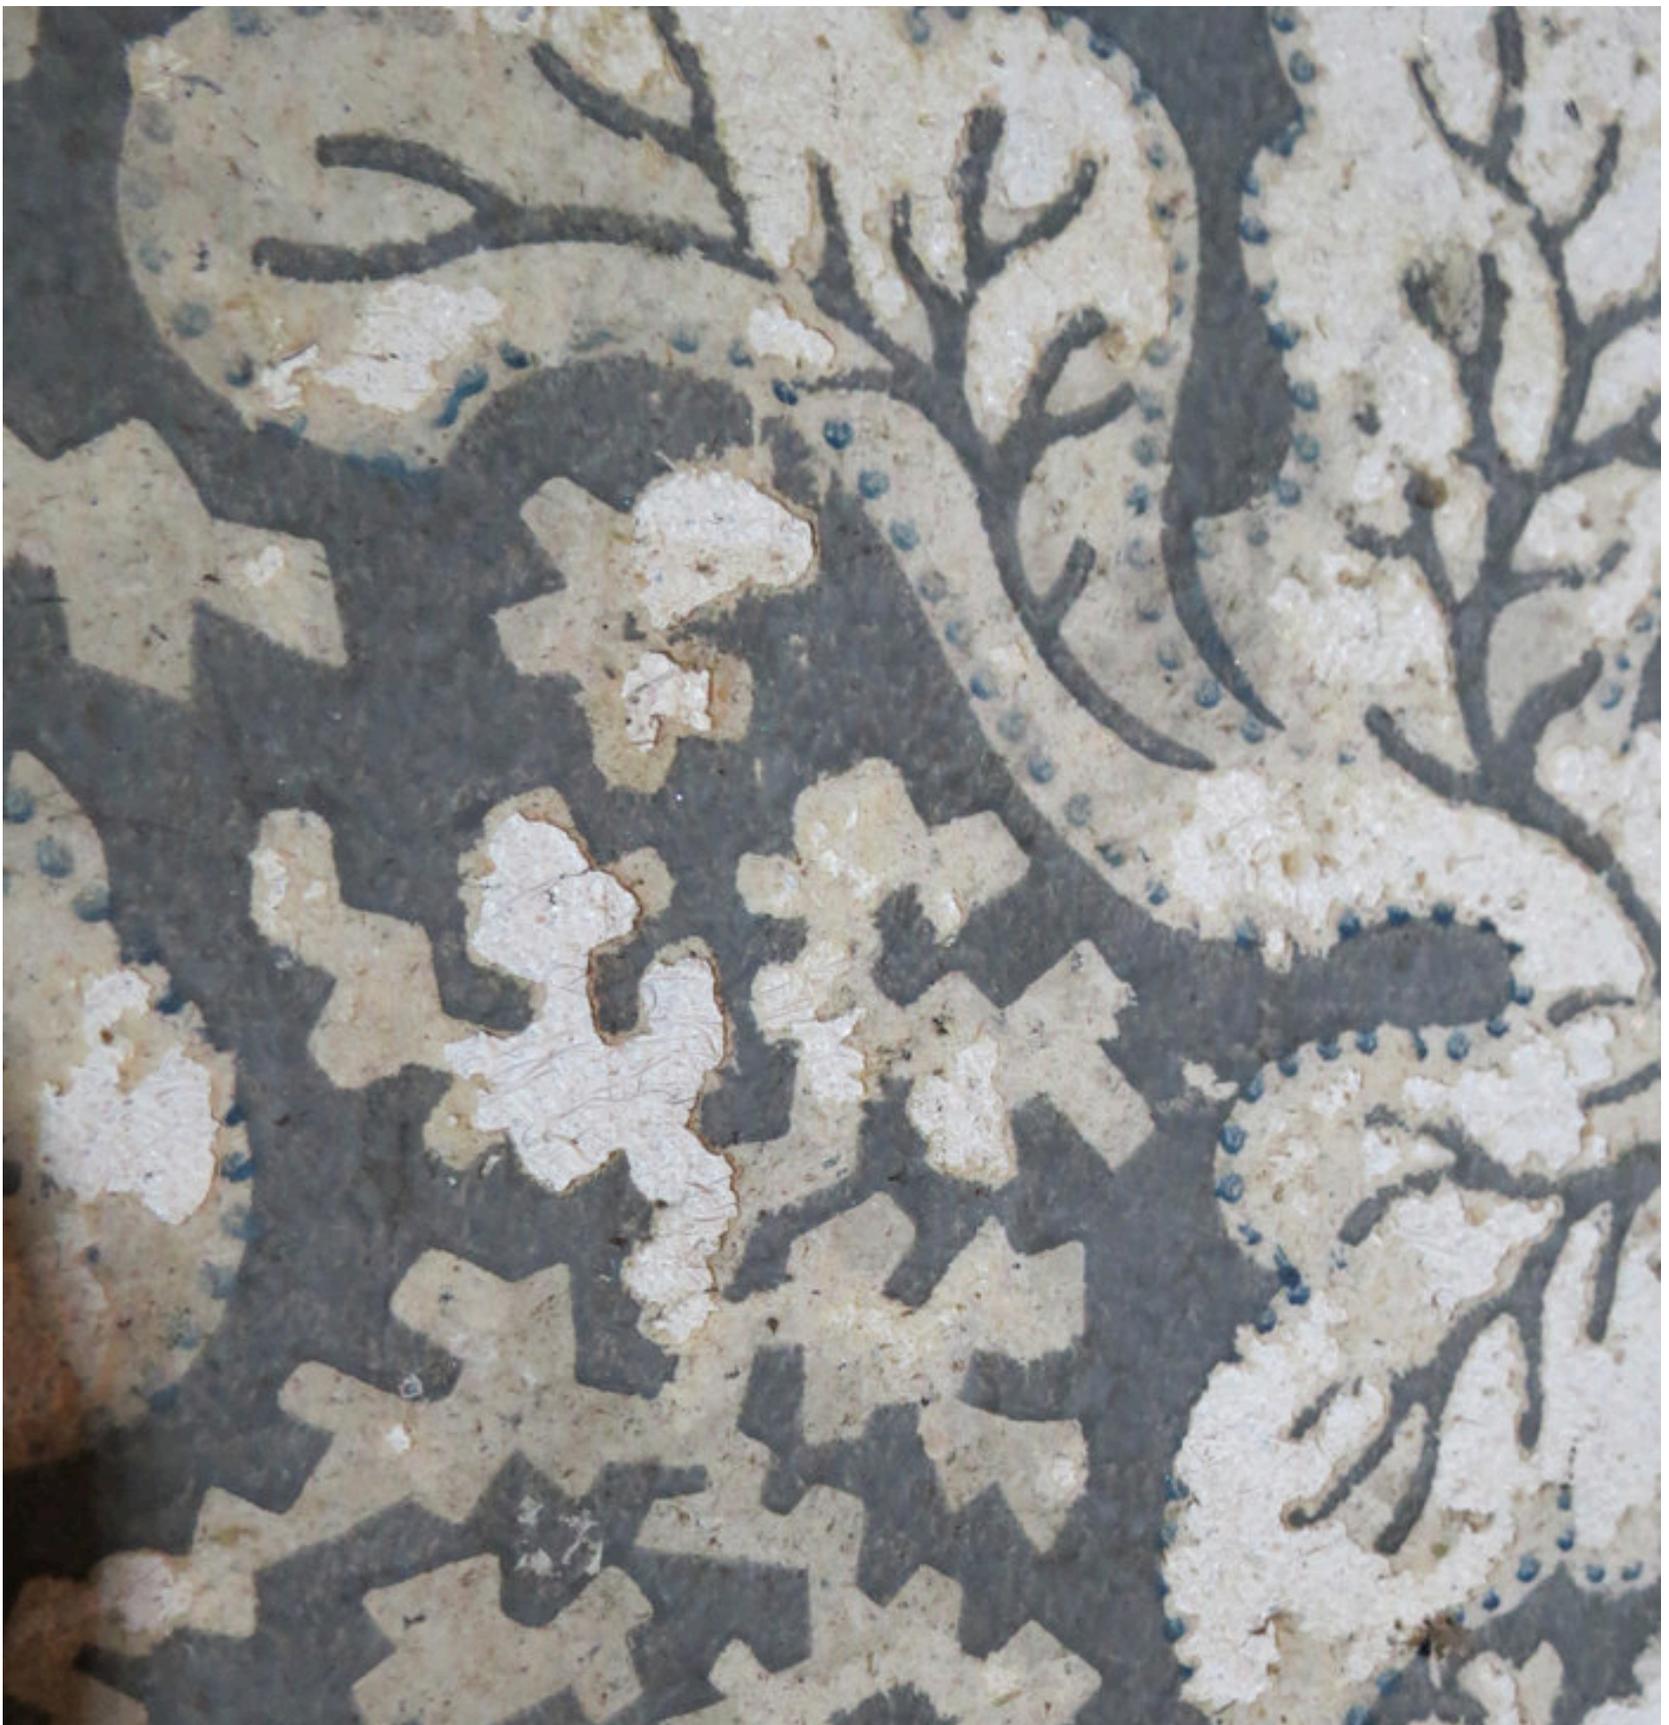
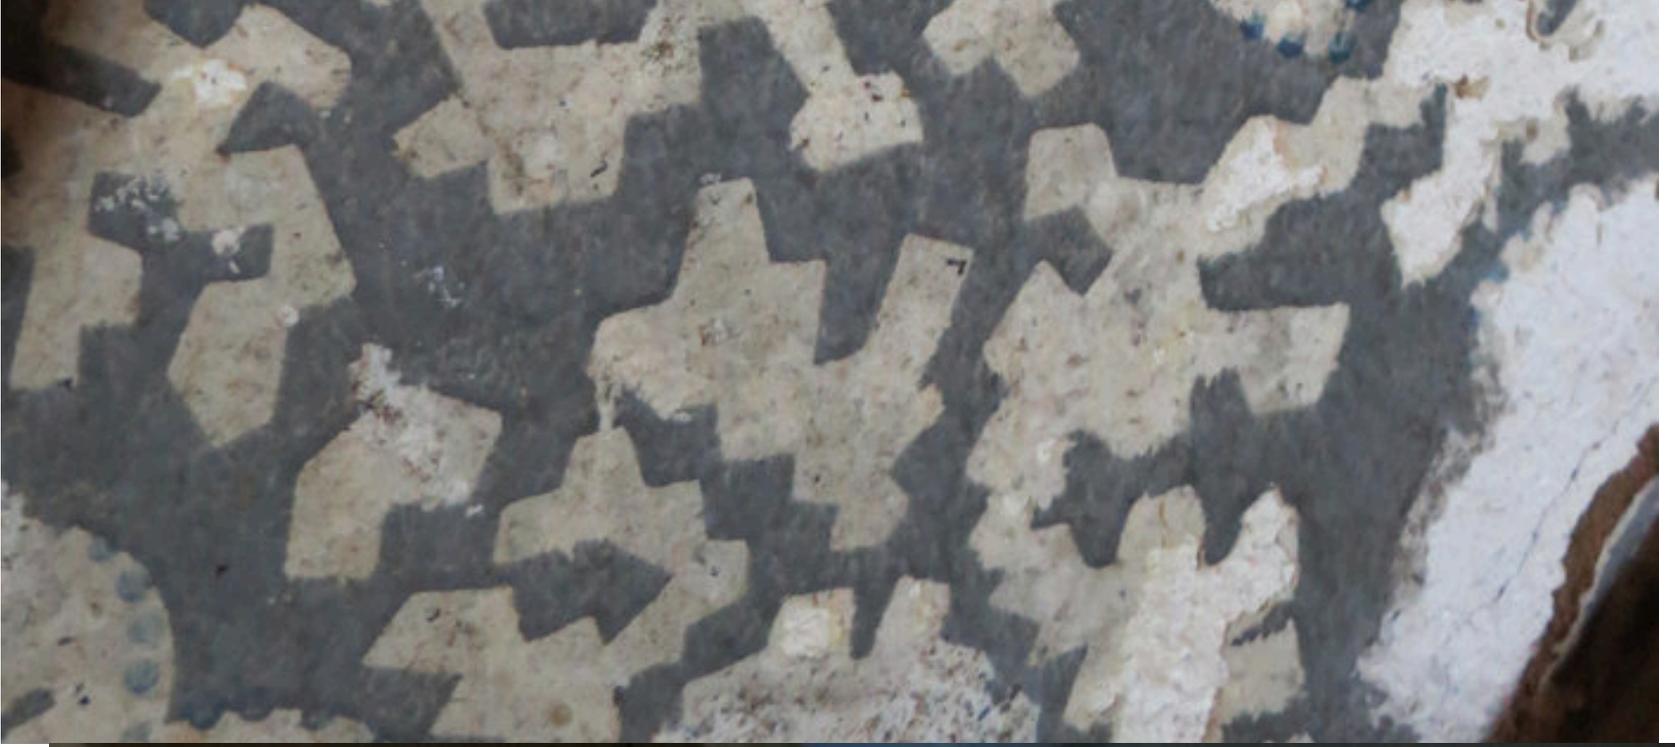
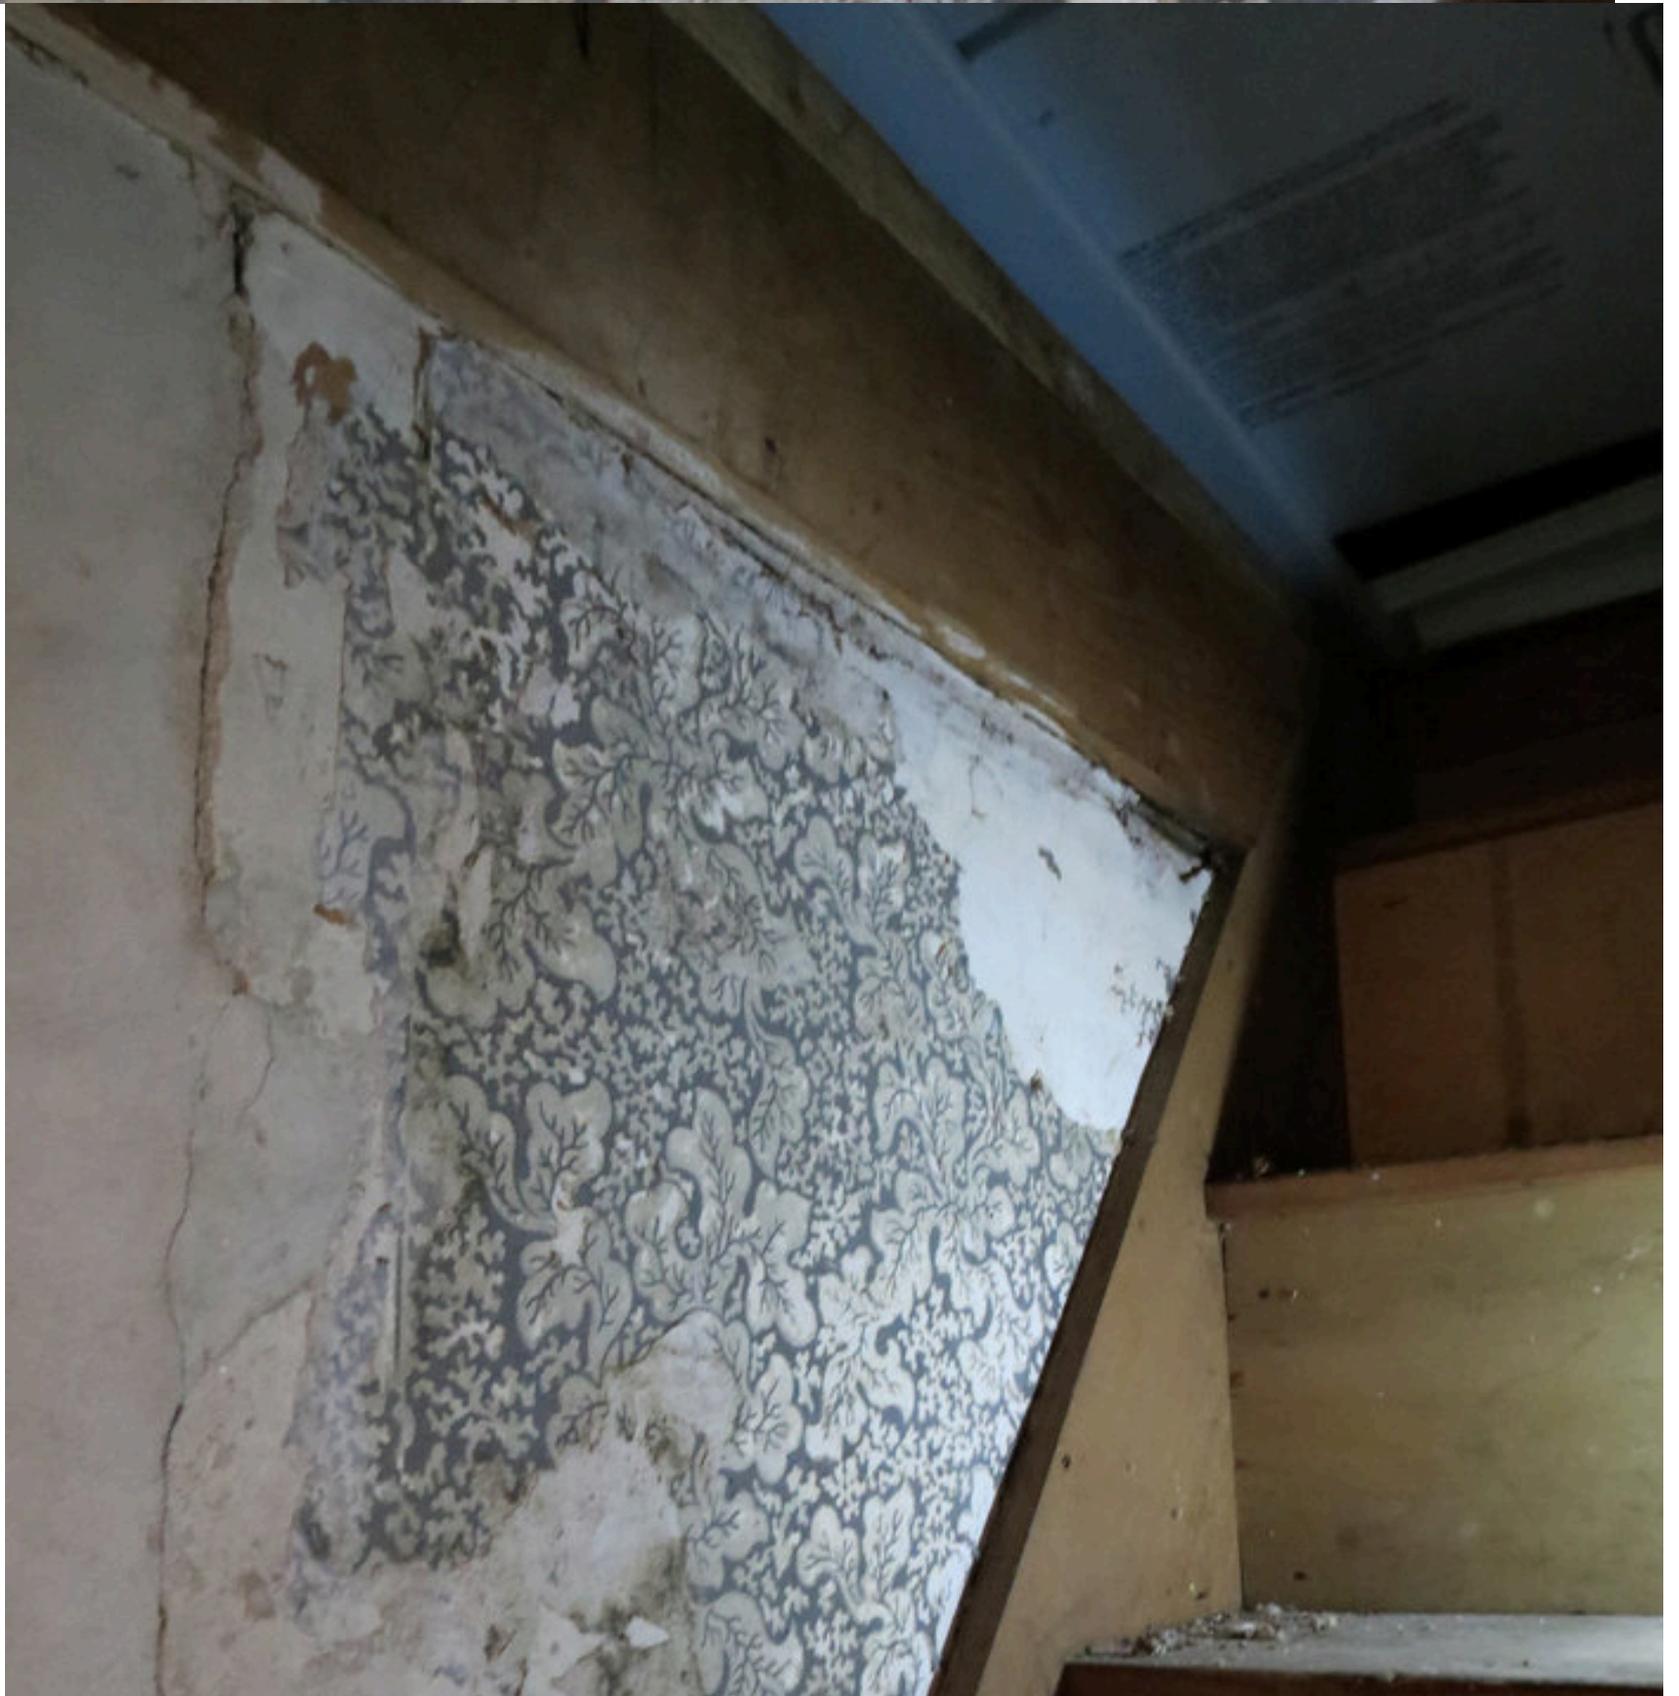
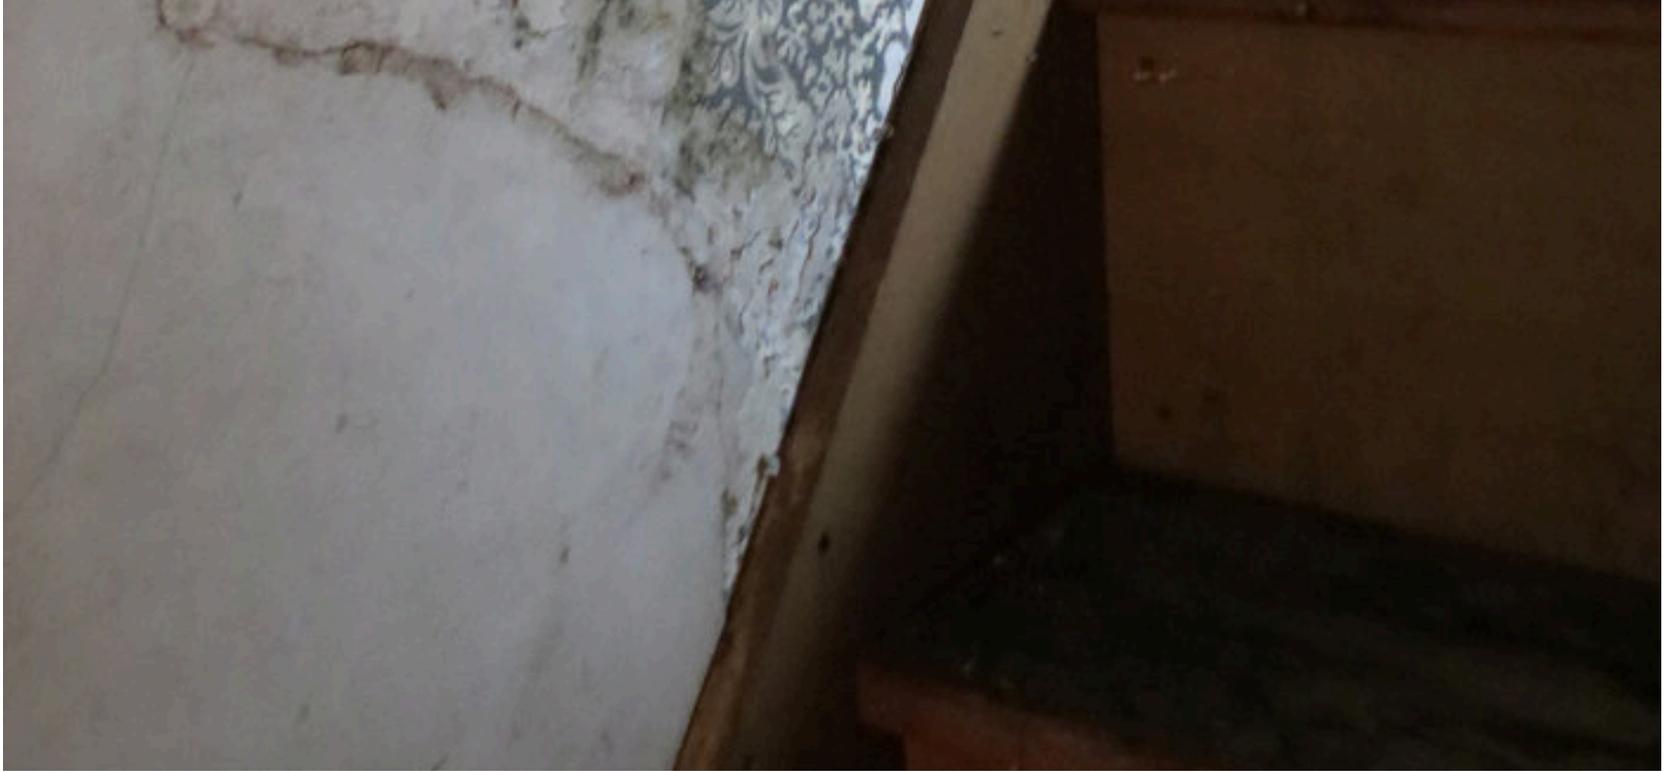
Then.... We heard from a fellow conservator who had documented a very similar observation in Topsham, ME. He had researched it and offered this conclusion: In the 1830 Topsham house on the walls of a plastered attic stairwell what remains is a delicate block printed paper floral pattern printed in what now appears to be dark gray and blue on a white ground.

As you can see in the photos, insects have eaten away entire portions of the off-white paper ground, which appear as a brighter white. Some of the close-up shots show areas that are only partially eaten away. This leads us to believe that the same thing has occurred in the Akin house.

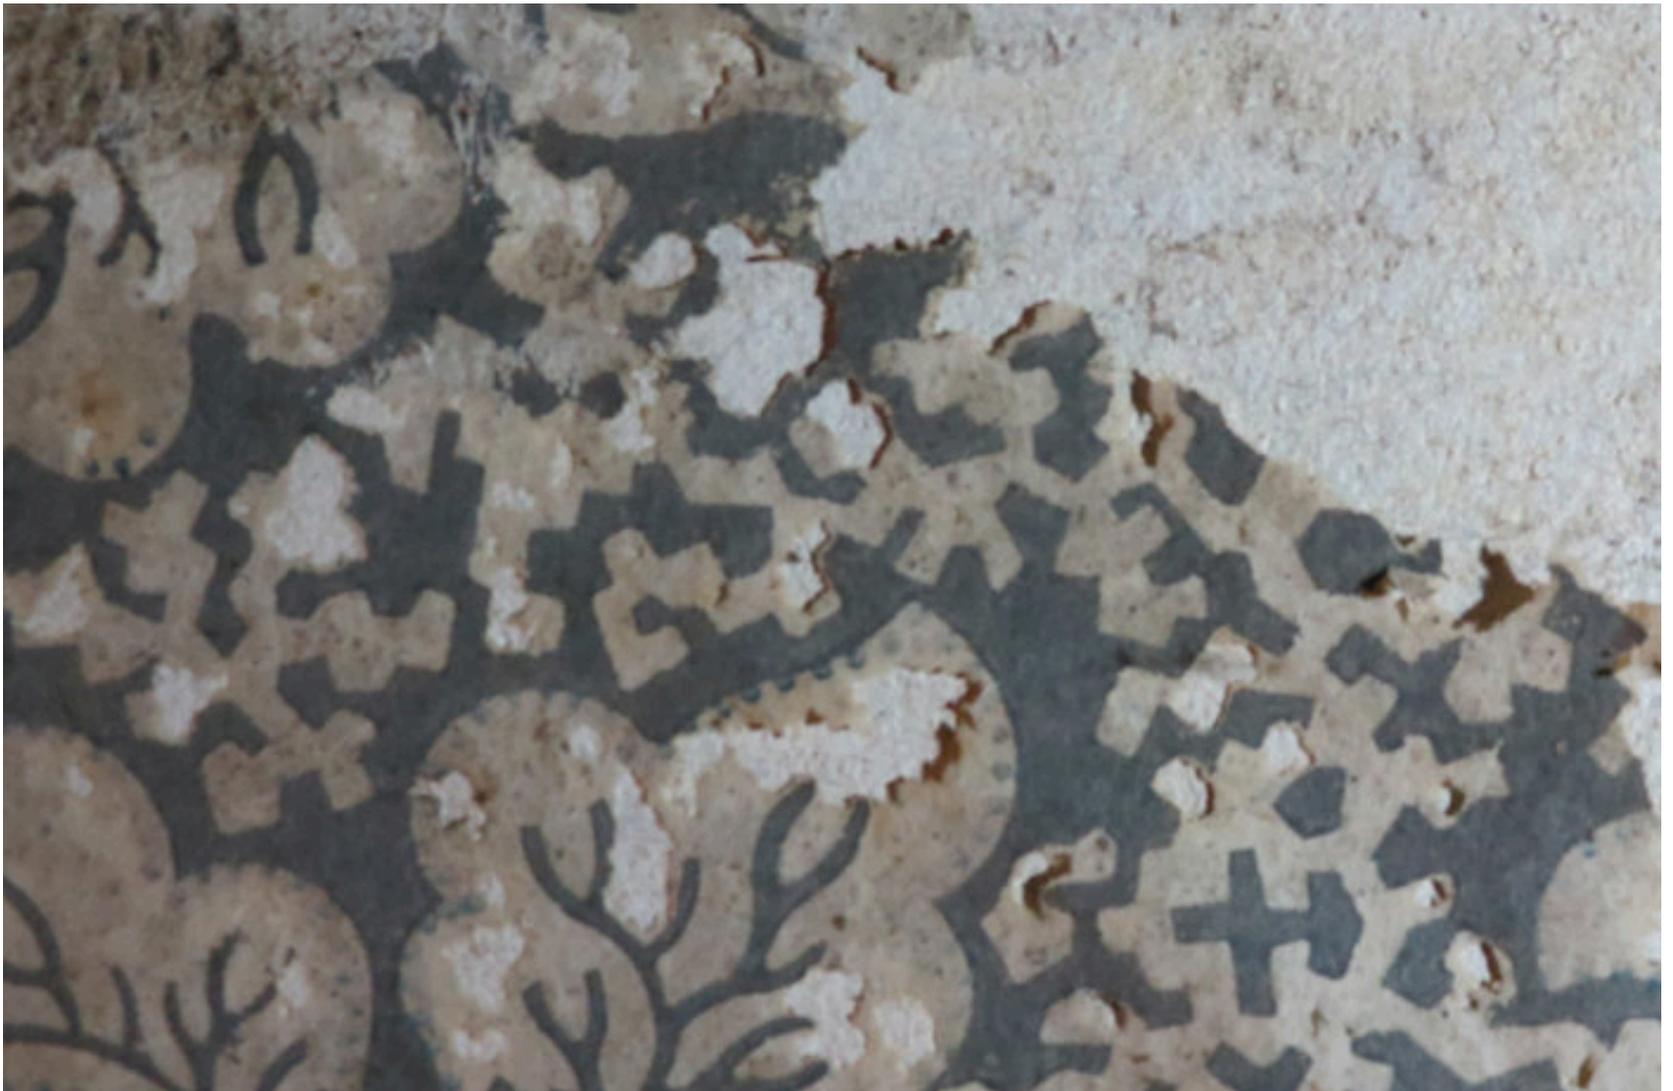
“The block printed foliate pattern, probably from the 1840’s, is typical of popular wallpaper designs of the 1845-1860 period,” says Richard Nylander, retired senior curator of Historic New England and wallpaper specialist. It is interesting that what appears to be the background color of the design is actually what was printed- just the reverse of the usual procedure of printing the design in colors on solid ground color.

After consulting an Entomologist we learned that the insect, most likely a silverfish, wants the starch in the paste but can sense the arsenic in the color before it's too late. They nibble around the toxic color and, in this case, leaving the deep verdigris pattern on the walls. This block printed paper dates from 1825 to 1840 and again the colors are typical of the period. A similar pattern can be found on Historic New England's collections data base - www.historicnewengland.org (<https://shoutout.wix.com/so/0LyigNzh/click?w=LS0tDQpkNmM2YWMyMy1mNmZhLTQ1ZGI0MjExNi0wZjE0MTkwYzI0MjcNCmh0dHA6Ly93d3cuaGlzdG9yaWNuZXdlbmdsYW5kLm9yZy8NCi0tLQ>) accession number 1923.241.
