2018 Second Quarter Report: Akin House Project Progress
prepared by Diane Gilbert, DHPT
July 23, 2018

About this report: Accomplishments or work in progress this quarter (April, May, June) with photographs illustrative of the work products have been combined into one report.

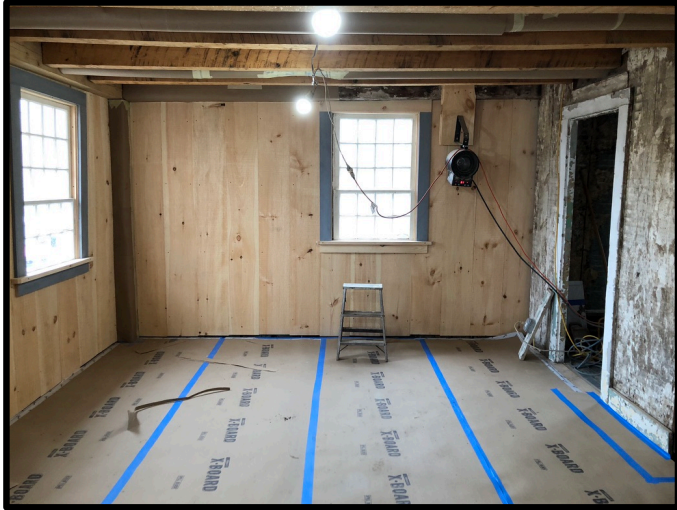
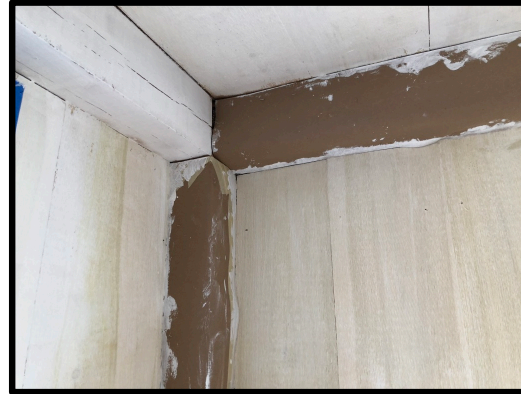
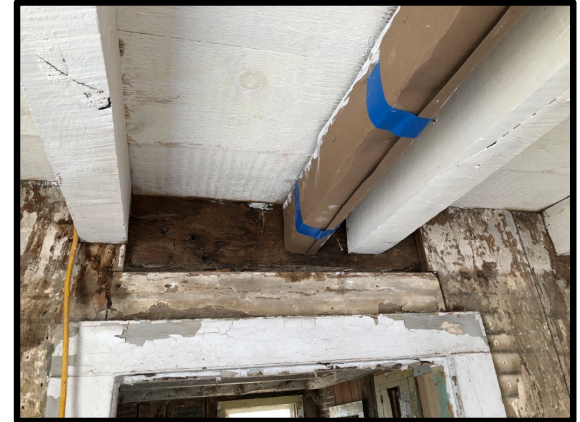
**Interior prep work and whitewashing to distinguish the old from the new.
(Keeping/Gathering Room)**

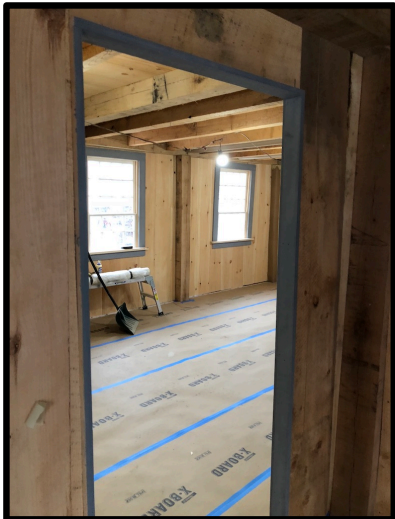
- Rough pine used as wall covering.
- Retained original wall substrate to show early whitewash and markings of the lath (with plaster) first applied to the walls throughout the house.
- The original joists and other early features covered for protection so that whitewash can be applied to new construction.

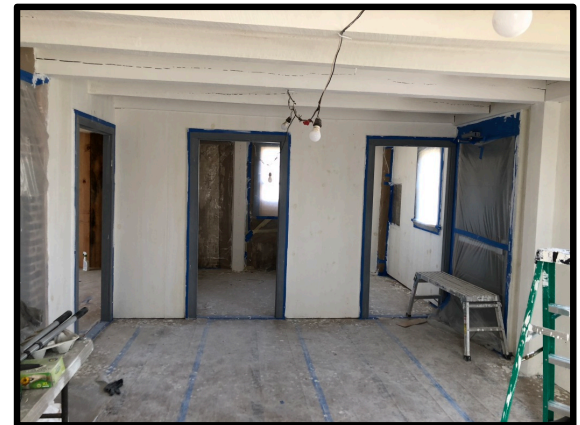
Details of the original construction

Upper left: original floorboards left exposed to contrast with the new. Chamfered timbers from the 17th & 18th centuries could have been elaborate or very simple depending on the house building style and always a function of capabilities of craftsmen and affordability. These original chamfered joists harken back before 1762.

Did Job Mosher recycle these joists or adopt earlier chamfering techniques? Reuse of materials was more commonplace then as now. The timbers coming from virgin forests after clearing for farmland ensured longevity.

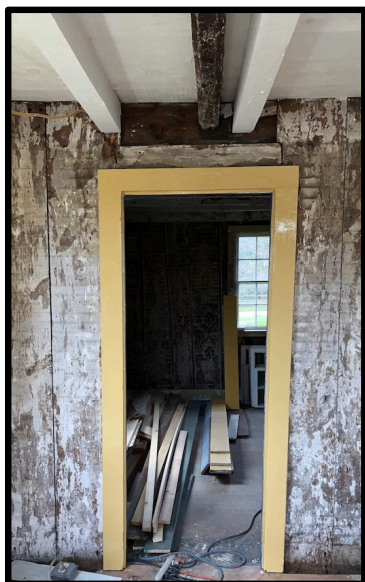
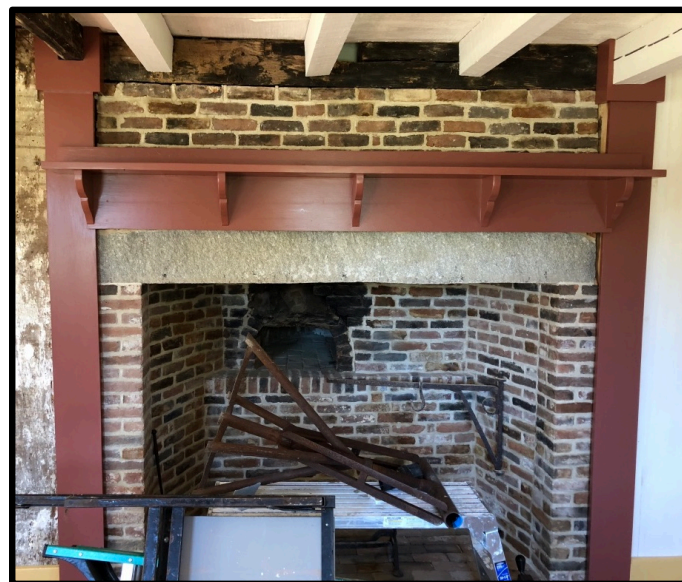
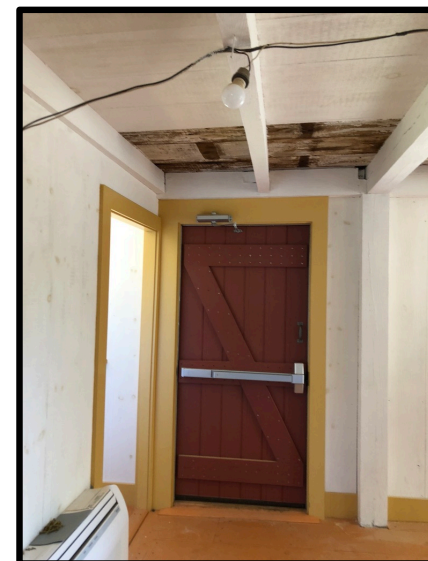
An examination of color choices. We selected historic colors of the Georgian period. We used Dorset Gold for the trim in the Keeping/Gathering Room along with the Buttery and the Boring Room to unify those spaces. The center photo shows a new mantel replicated from the ca. 1760s Hanford-Silliman House in New Canaan, CT. We have no extant evidence of the original mantel for the cooking hearth. Cogswell Cedar matches the rear entry door built for primary, universal access. Pumpkin chosen for the pine floors installed in 2009 and 2017. *Replica mantel and paint colors approved by MHC and Historic New England.*

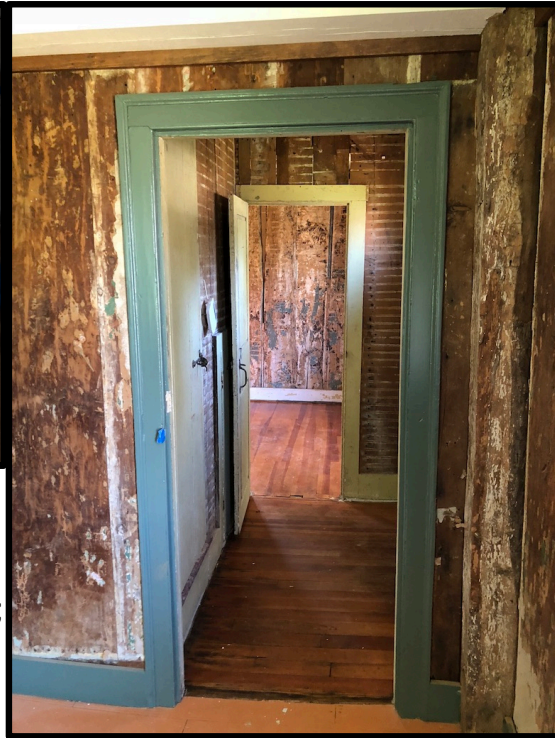
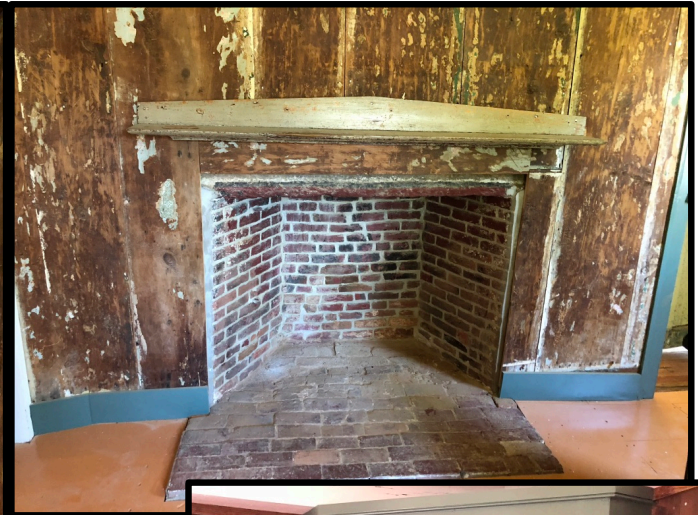
Other photos of the **Formal Parlor**. Center: the Federal style doorway leading into the Foyer with original doorway leading to the small parlor in the background. Upper right: the Greek Revival fireplace and hearth topped by Greek Revival mantel scraped down to its original color and left as is, surrounded by original wall panels. Right: the restored corner cupboard, known as a beaufait, ca. late 18th century, surrounded by new wide pine wall panels stained to conform with the original wall panels although obvious new construction. Caldwell Green selected for this room, a color that closely resembles the first layer of paint in the original corner cupboard. This room represents three periods, Georgian, Federal and Greek Revival.

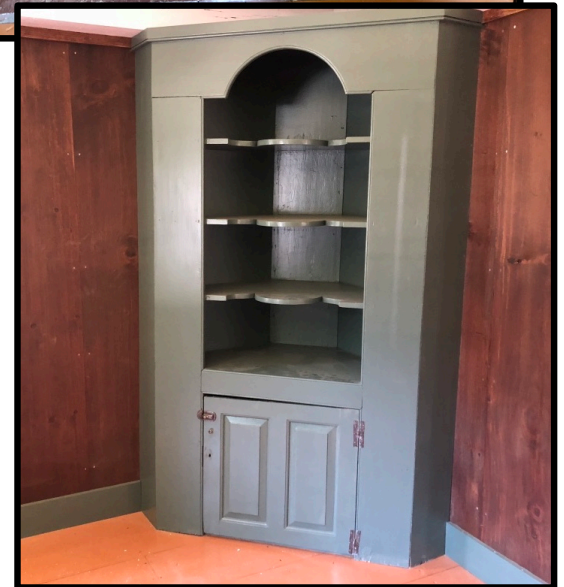
Below: An example of a historically appropriate repair of the late 19th century floor in the Foyer, using just a strip of planed wood of the same vintage and period found in the house.

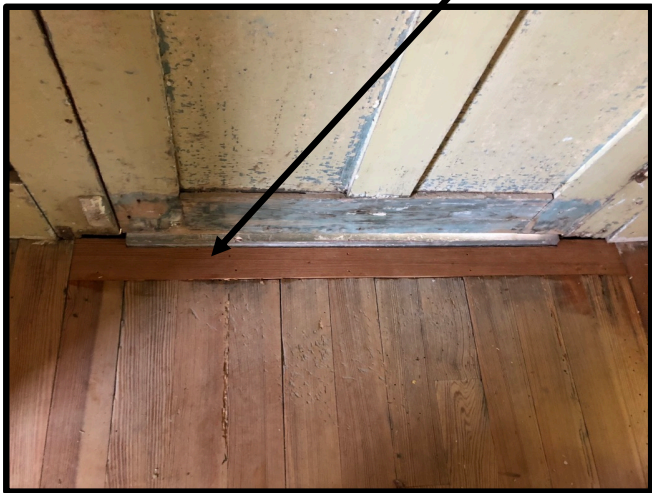
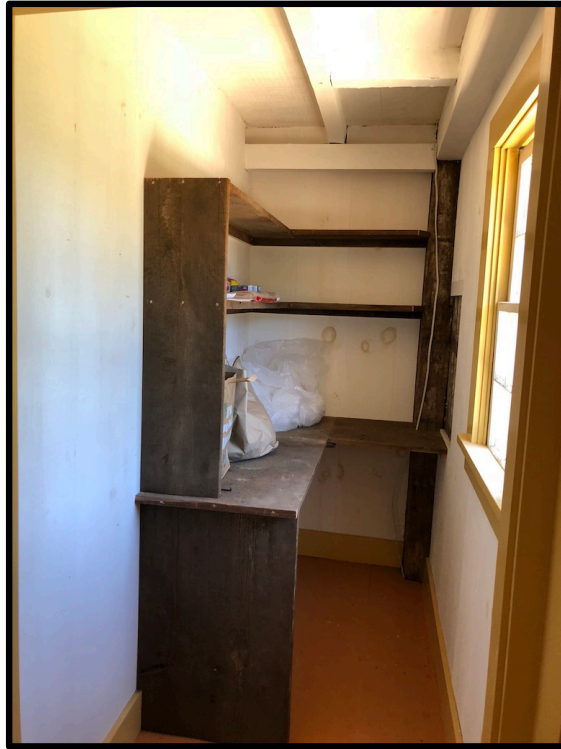
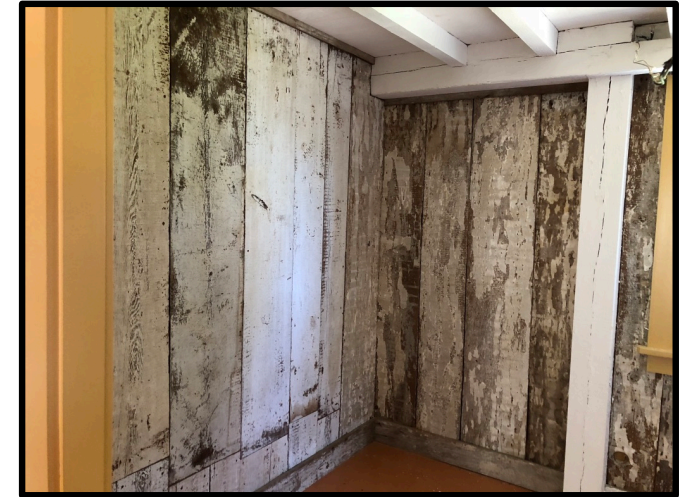
Above: View of the Borning Room paneled with original white washed boards. This room will be used as a library, for research, and small scale interpretive presentations using technology.

Above: The Buttery has been outfitted with shelves to display pottery, crockery, jugs, dishes, baskets, cooking utensils and other tools typically used by inhabitants of the period. The shelves were made with wood discovered in the upper eaves of the second story. The Buttery will be furnished as vintage items are purchased, found, or donated.

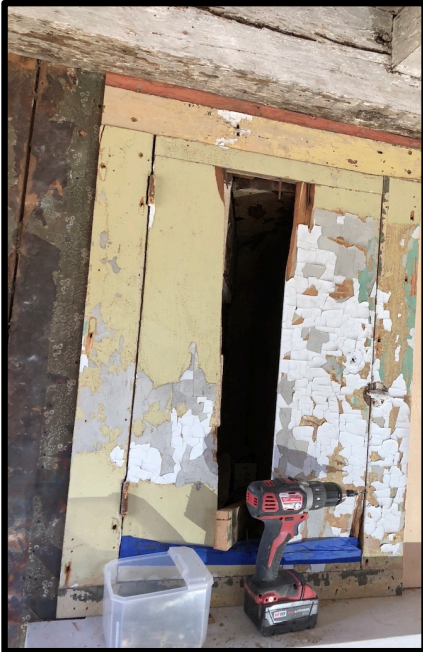
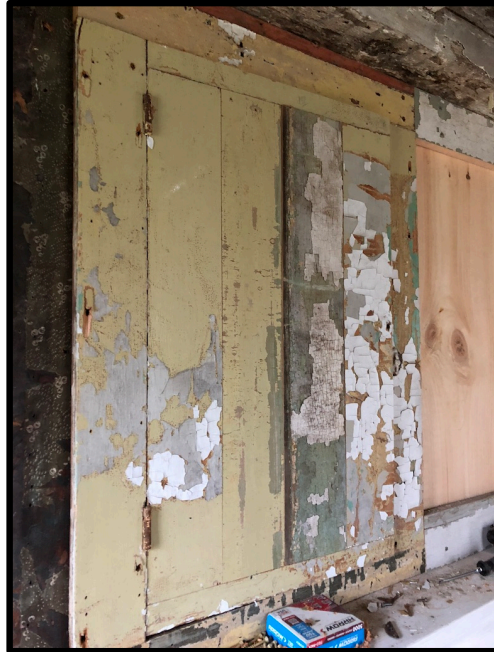
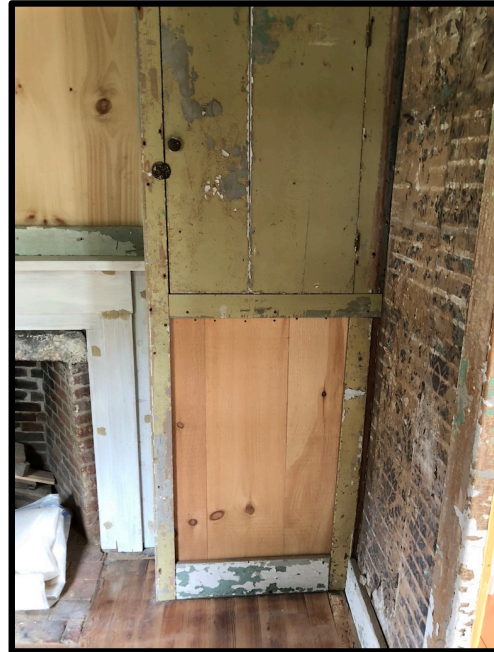
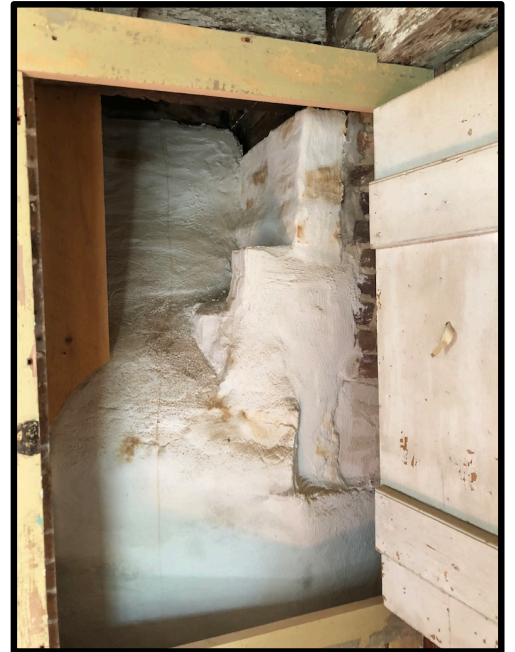
Sitting Room/Small Parlor

The above cabinet was repaired with reused wood plank pieces salvaged from this room.

The above cabinet to the left of the Greek Revival fireplace was restored with few alterations. A plaster & lath wall below the cupboard was removed to expose the chimney for repairs and replaced with Similar rough pine panels installed throughout the house. The door now opens to reveal a back view of the parged chimney, rebuilt to accommodate the original cooking hearth in the Keeping/Great Room.

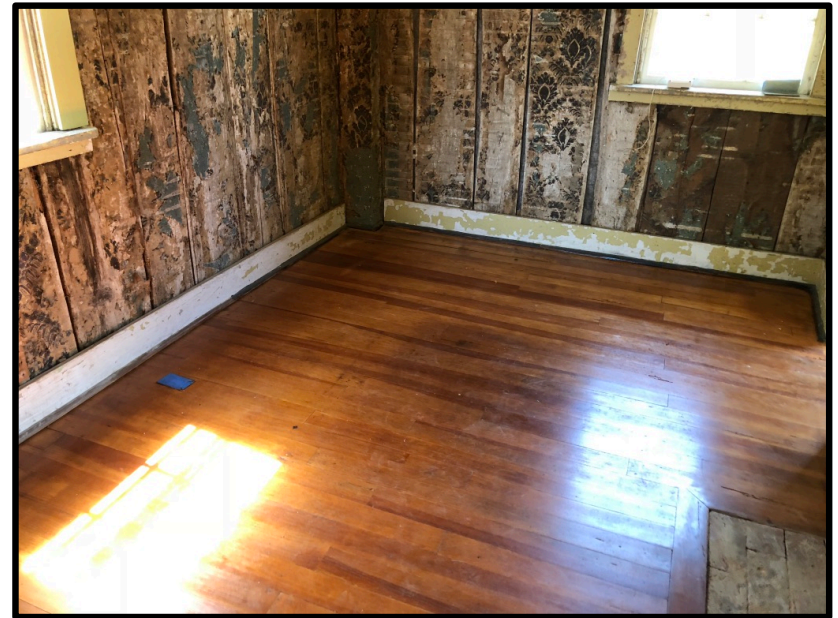
Sitting Room/Small Parlor

Henderson Buff was used to paint the restored mantel, the pine panels, and the trim because it is a close match to the early green-yellow layer revealed in this room and foyer. The floor of hard yellow pine (extending to the Foyer) was sanded and finished with a sealant and poly oil finish for durability. Because of this room's exceptional and rare qualities such as the wall covering of 18th century English wallpaper, as was suggested by wallpaper experts, it will be used as a exhibition space requiring special conservation treatment.

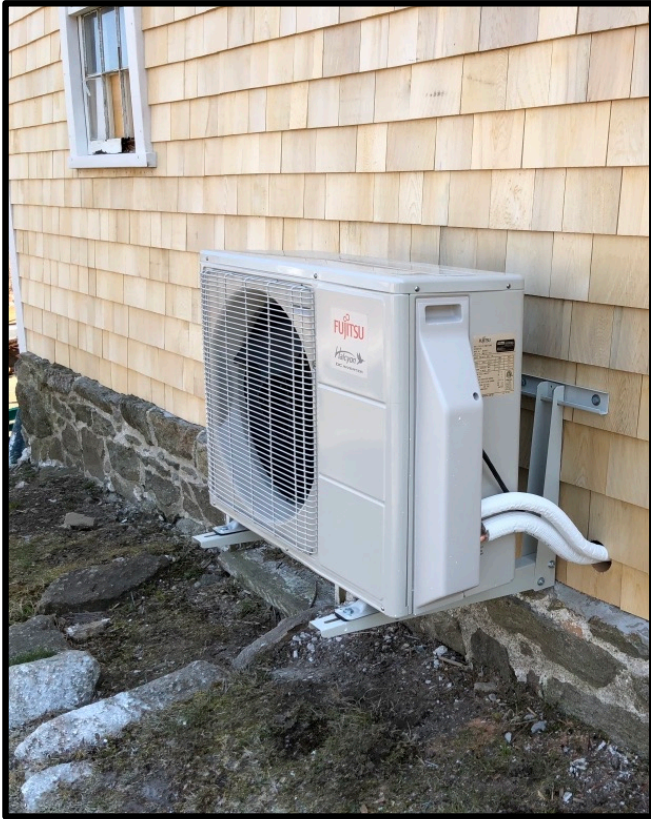
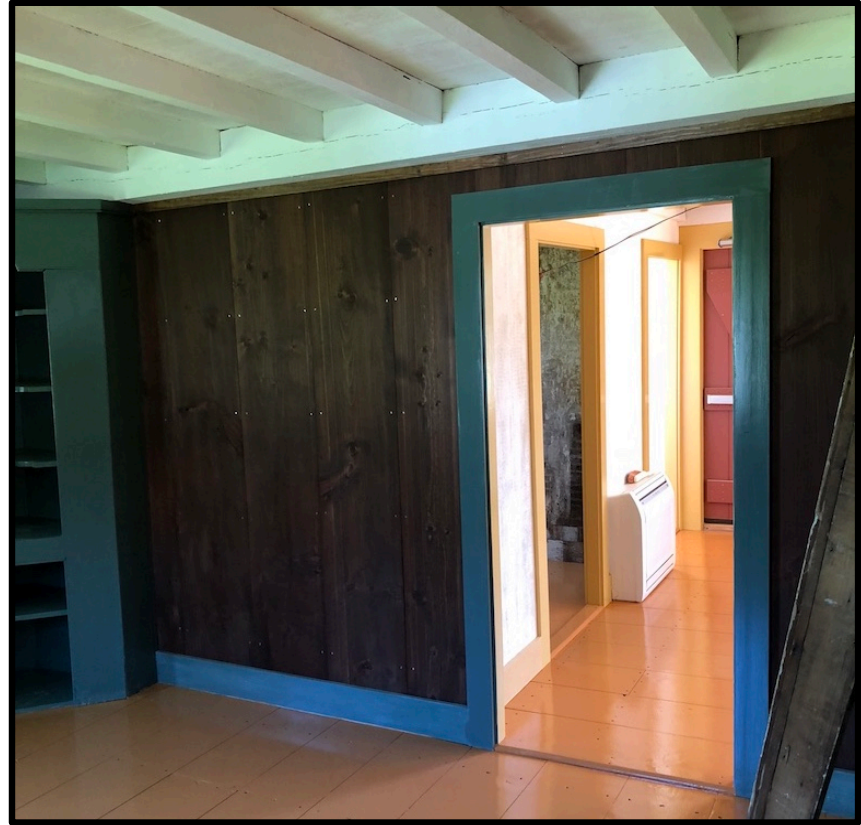
The Fujitsu combination heat and AC unit was installed this quarter. The exterior compressor is located on the North elevation and will be camouflaged with vegetation. A view from the Formal Parlor shows the unit installed in the Keeping/Great Room in between the Borning Room and Buttery.
