### 18.78 Elihu Akin House (ca.1762) Parlor Wallpaper

#### The Elihu Akin House

The wallpaper remnants within the South Parlor are the subject of this report.

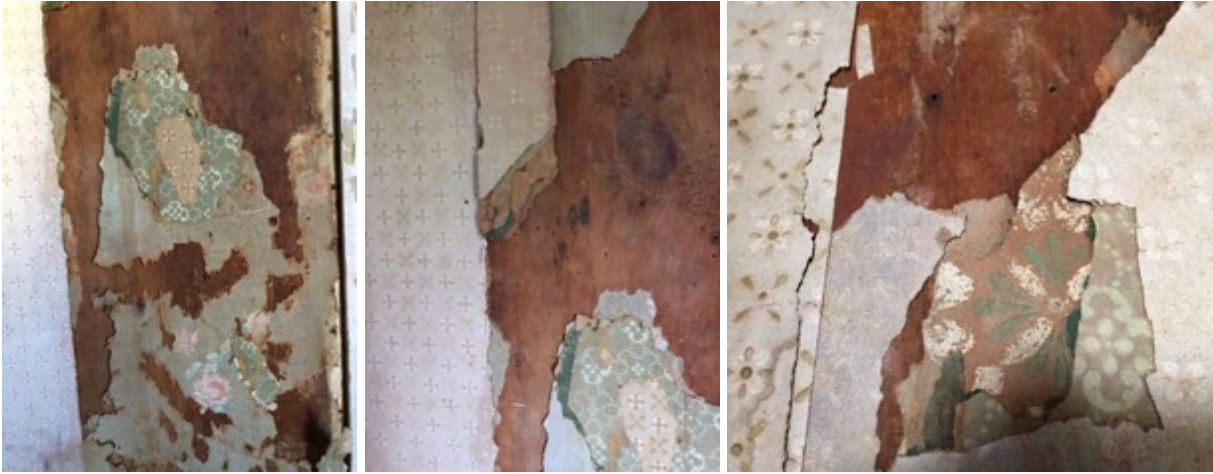
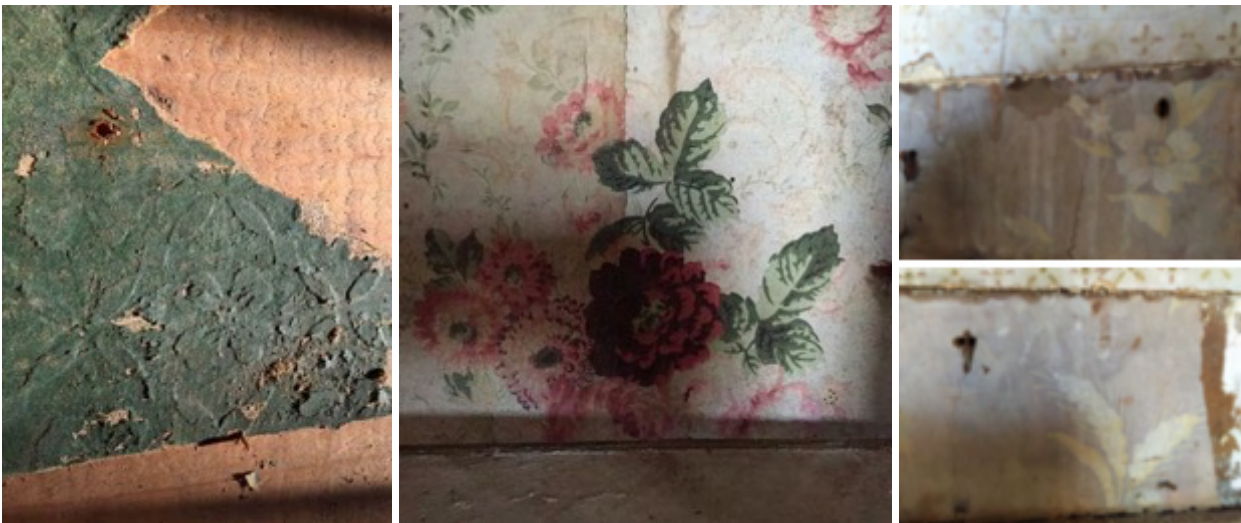
Wallpaper layers photographed by D. Gilbert prior to removal from the North Parlor walls.

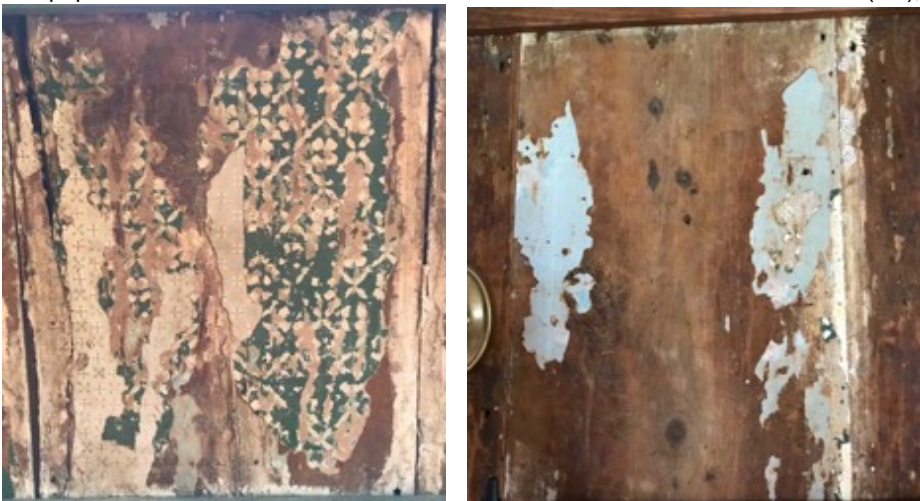
Wallpaper remnants retained on the North Parlor walls beneath the West window (left), to left of the fireplace mantel (right)

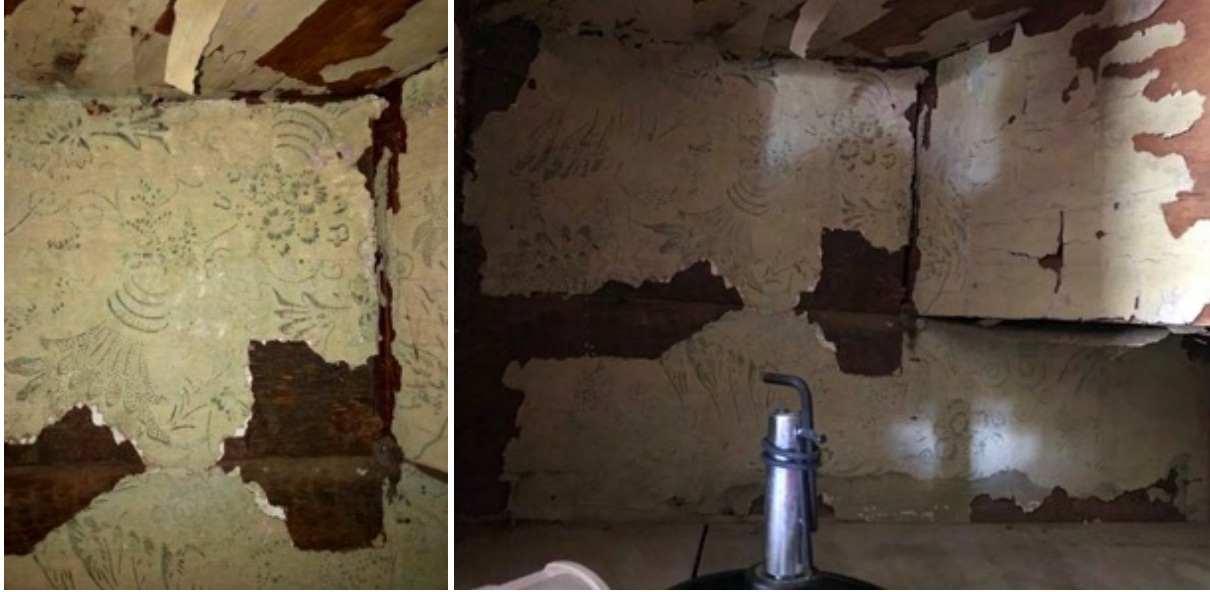
Wallpaper fragments found in the interior of the cupboard to the left of the mantel in the South Parlor

Identified by DHPT within the collection of Historic New England, as GUSN-296581, WP368, maker unknown, ca. 1840-1860. Machine printed.

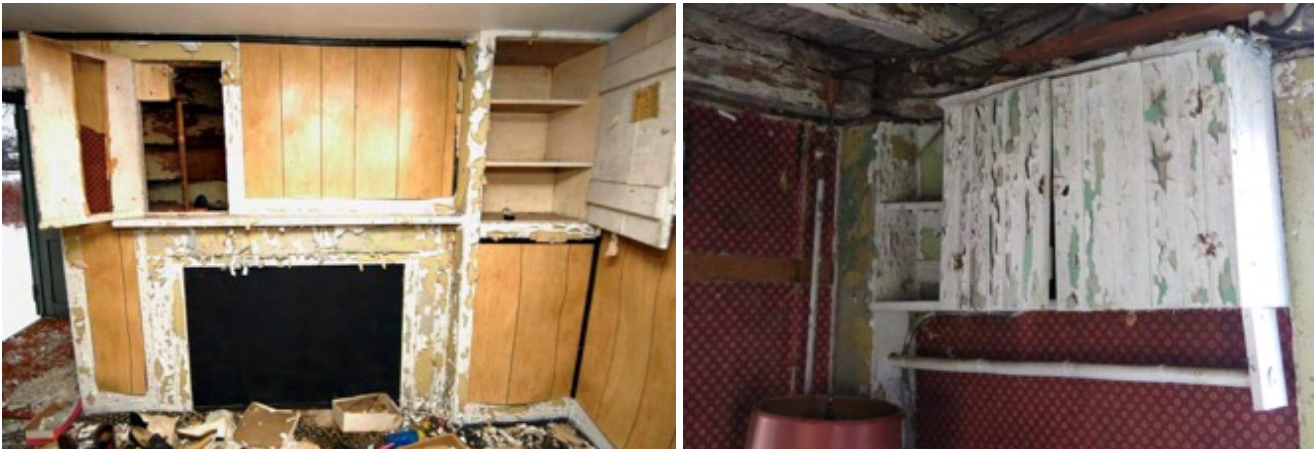
Paneling covered walls of South Parlor, 2003 (left) & the most recent wallpaper installation, a rose-colored floral pattern paper (right).

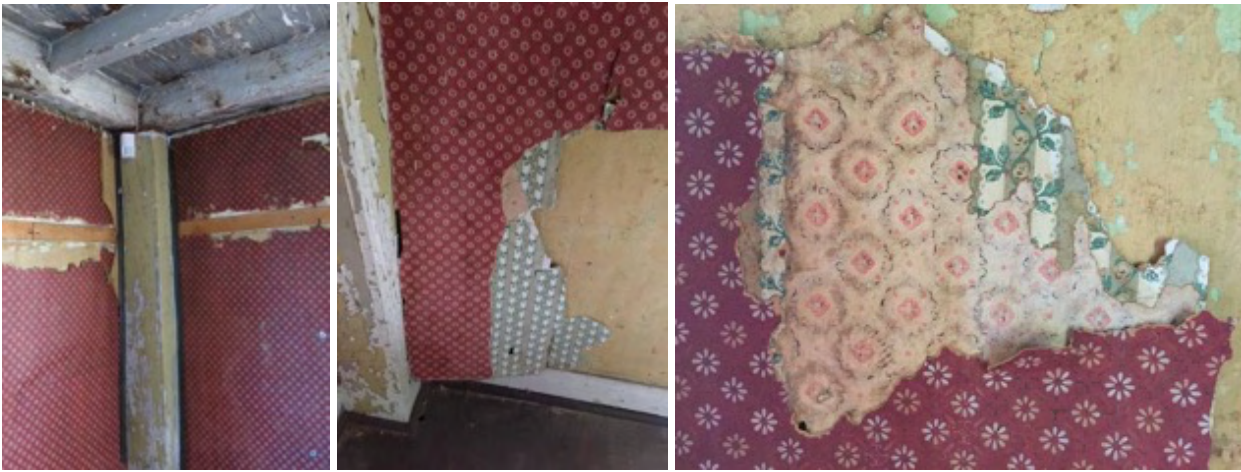
Most recent wallpaper layering

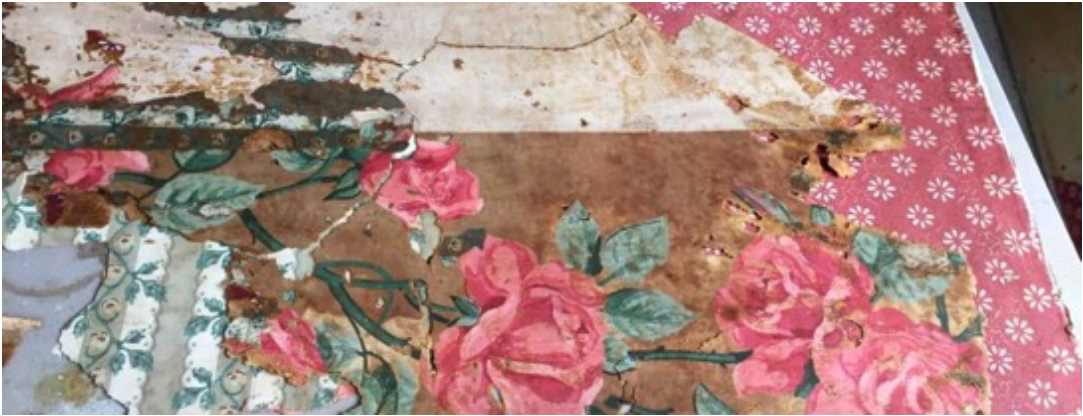
20<sup>th</sup> century wallpaper stratigraphy

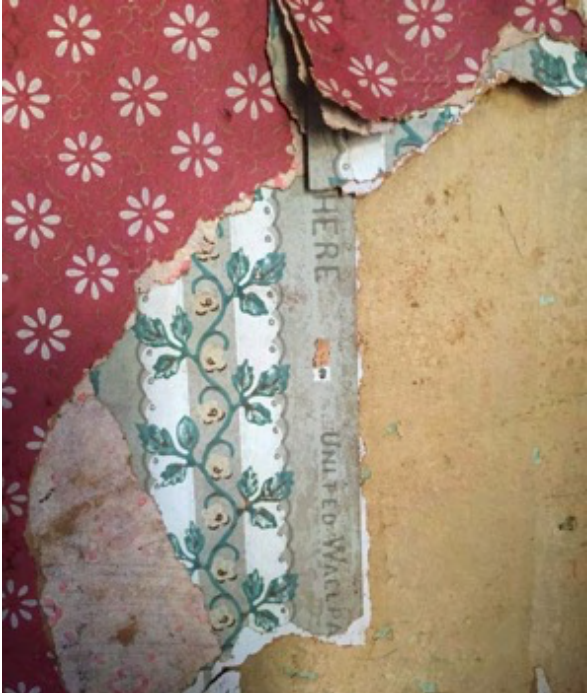
20<sup>th</sup> century wallpaper stratigraphy atop plasterboard

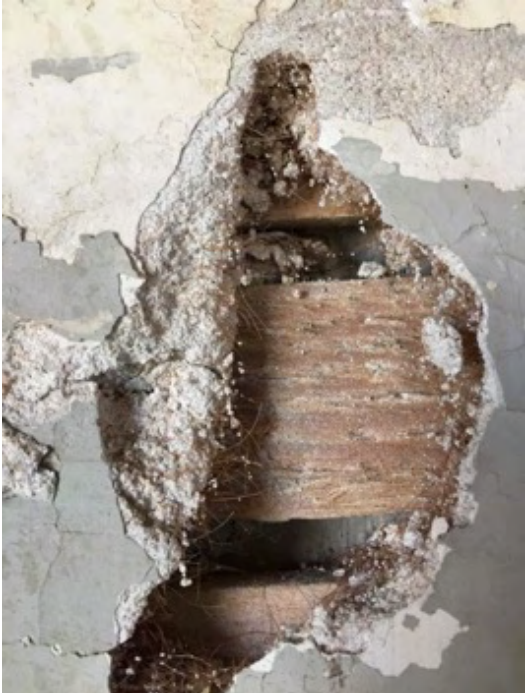
Underlying plaster & lath wall structure

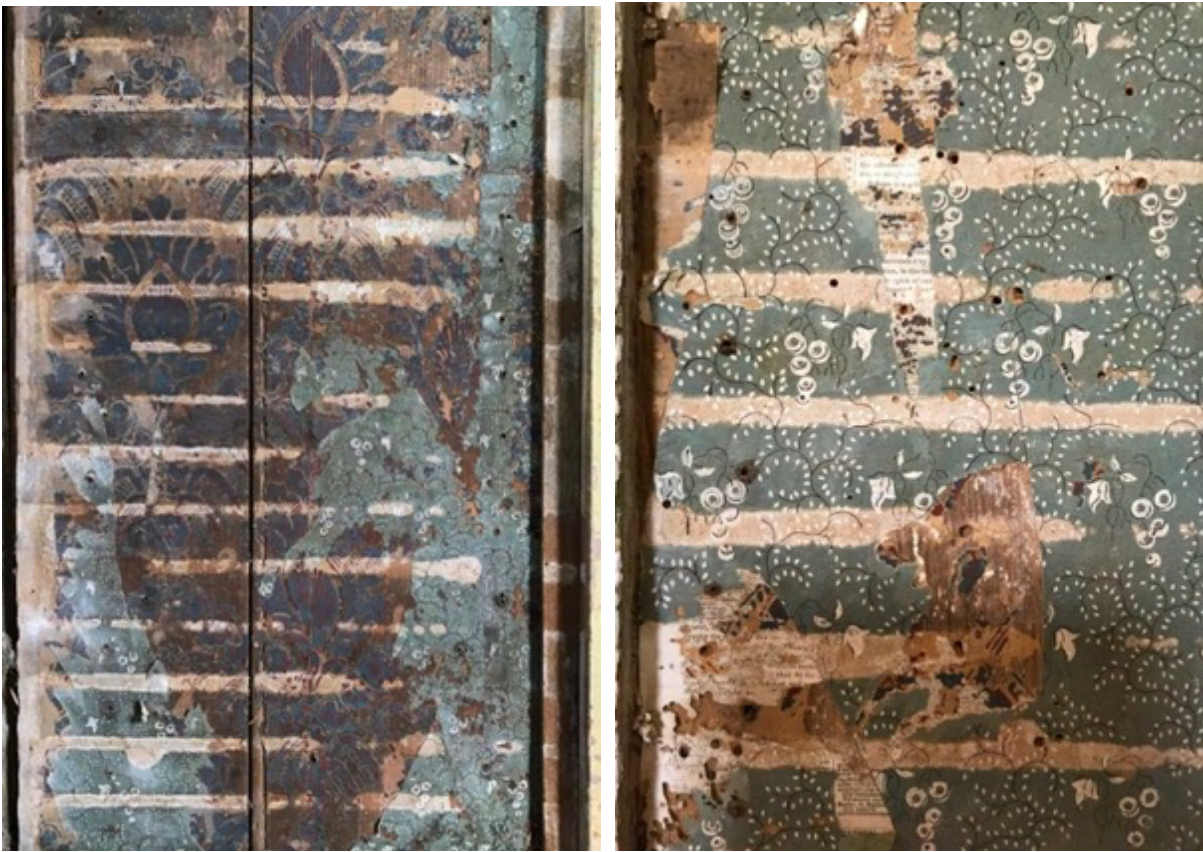
Wallpaper fragments revealed on the original wall surface upon removal of the plaster & lath surface wall.

Three layers of paper were revealed following the removal of 20<sup>th</sup> century wood paneling, plasterboard and early plaster and lath walls. The wallpaper is adhered directly to whitewashed wide wood plank interior and exterior walls. The wood planks range in width up to 15 inches. The wallpaper is installed from the floor to the ceiling joists for a height of approximately 6' 10" though it is covered by a painted flat profile 5-6" wood baseboard with a black ¼ inch round molding at the floor in some areas. Fragments of the earliest wallpaper are present on all of the wall surfaces with the exception of the north overdoor which appears to have replacement wood planks, totaling approximately 142 square feet of wallpaper.

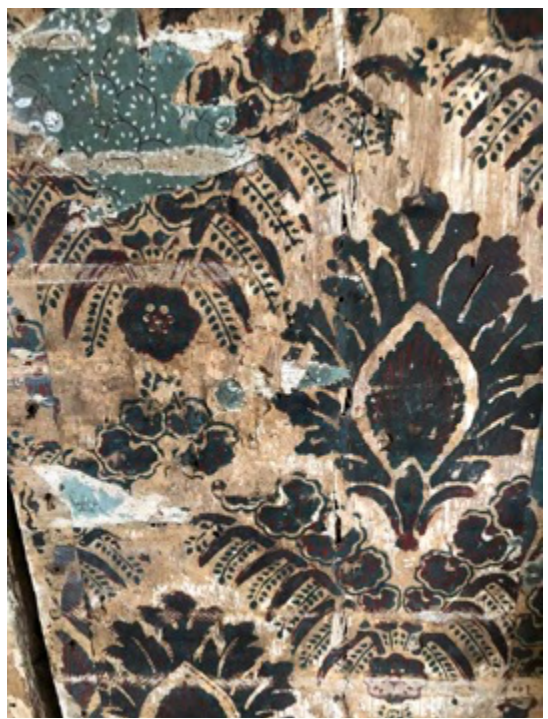
Photographed with studio lights

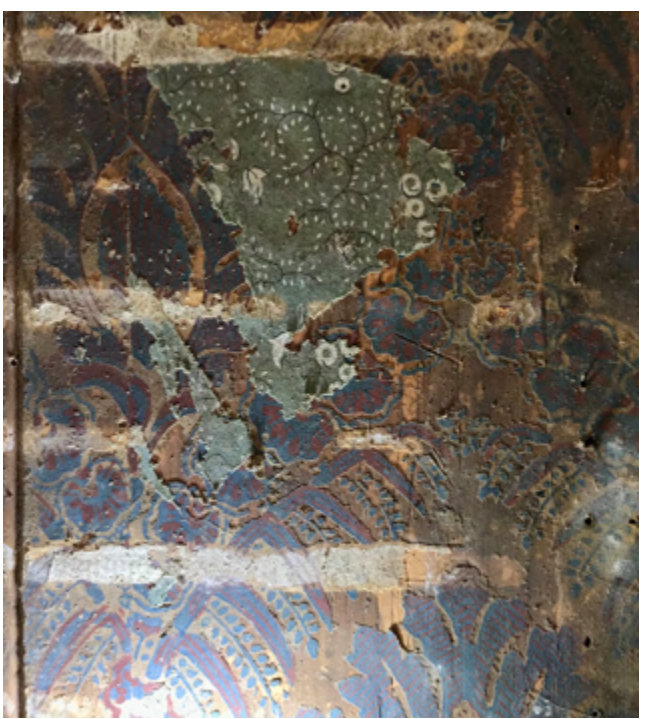
Photographed with raking light to capture 3-dimensionality of layers

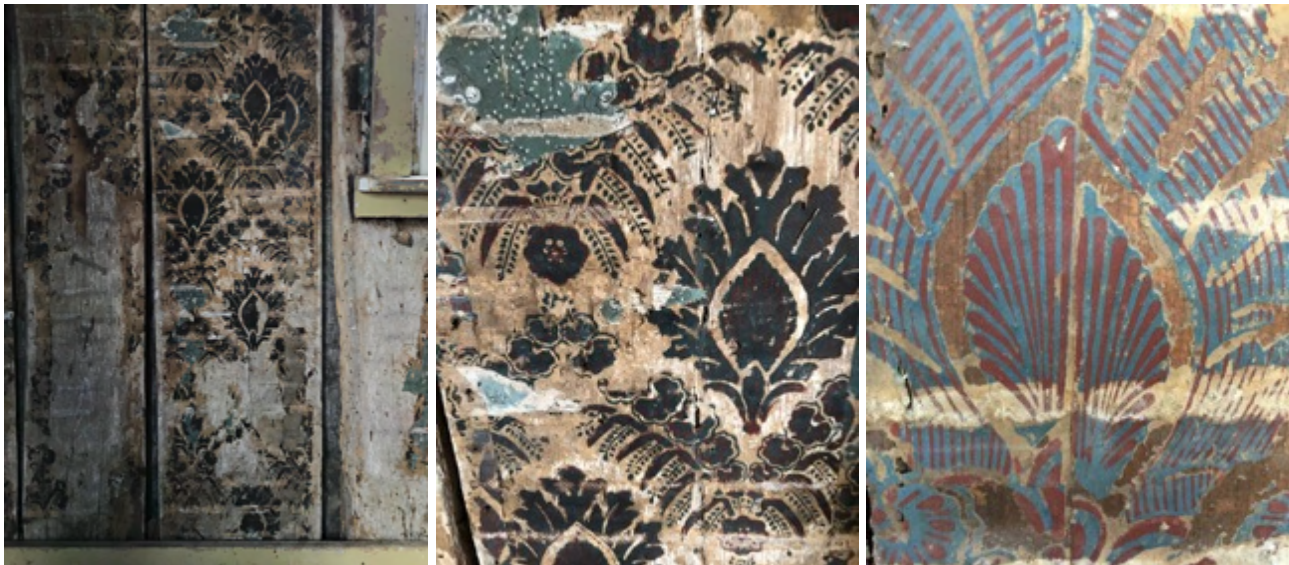
Width of the paper is 19 ½ inches with nearly an inch underlap. The wallpaper design exposure measures approximately 18 ¾ inches wide with the vertical repeat every 16 inches. On the north side of the east wall, the largest vertical fragment measured 52 inches without a visible horizontal seam. Likewise, a fragment to the right of the window on the south wall measured more than 40 inches in height. This indicates that the wallpaper was printed on machine-made roll paper and not handmade sheets assembled into rolls, as was the convention prior to the invention of machine made paper. Therefore, the palmette paper most likely dates to 1820-30 or later.

Central plank exhibits offset palmette pattern (left), Detail of palmette with laurel & cascading leaves (center), Wallpaper seam at the center of the palmette installed slightly out of alignment (right)

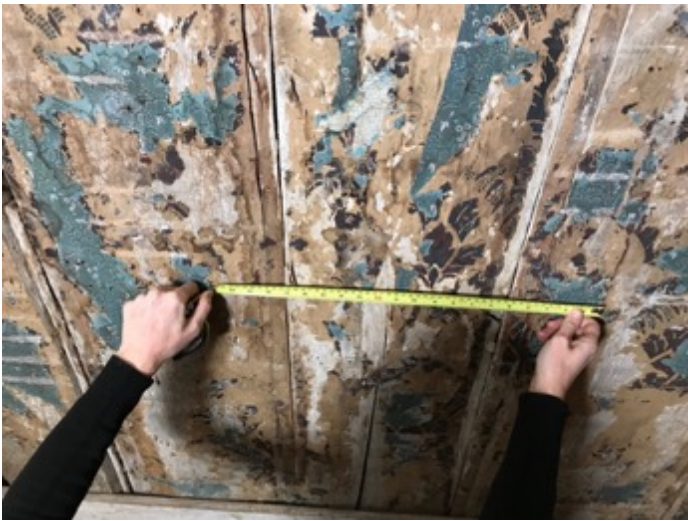
Measuring the roll width from seam to seam (south wall)

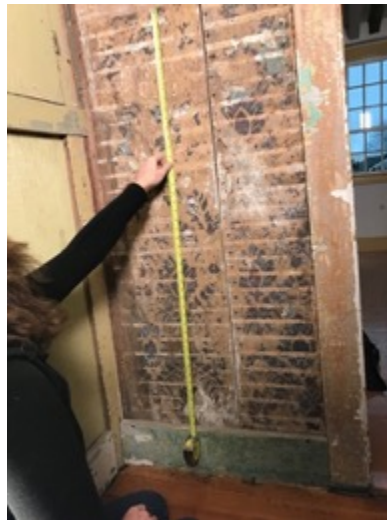
Measuring continuous paper height (east wall)

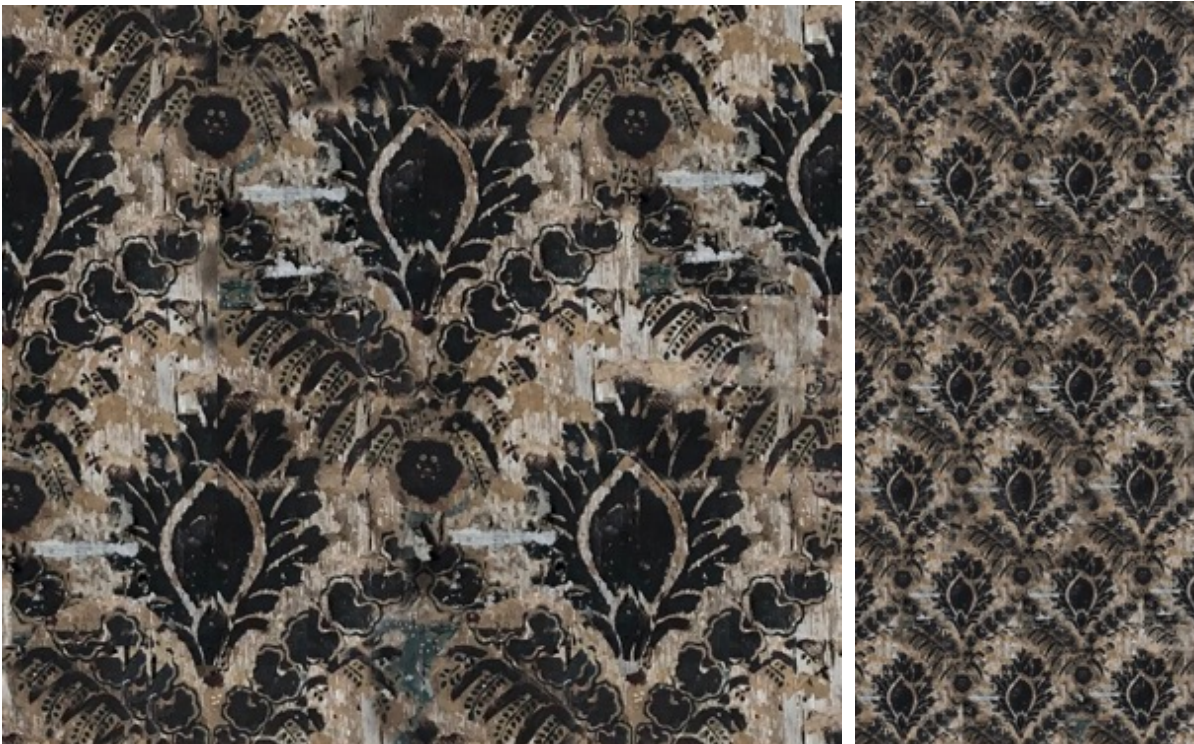
Rudimentary reconstruction of single palmette repeat (left) & palmette pattern (right).

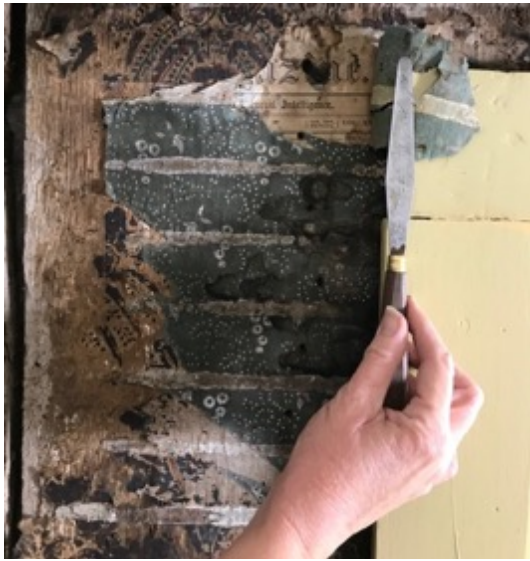
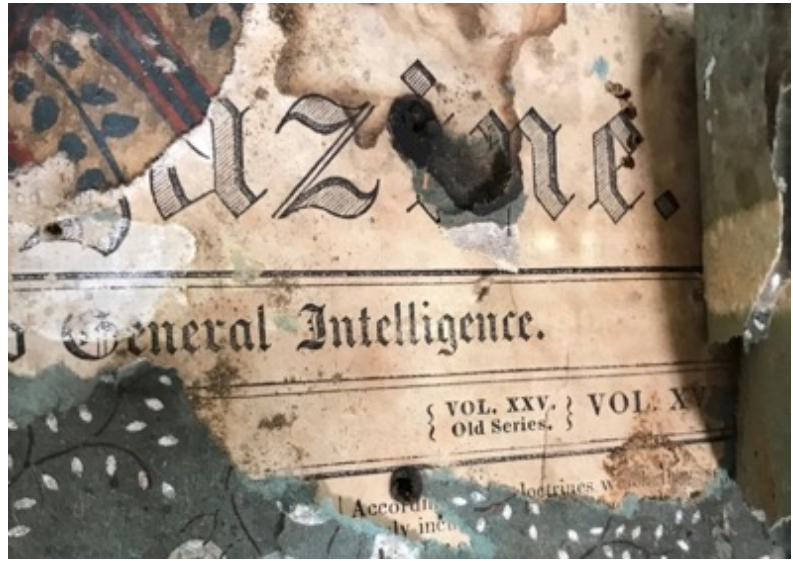
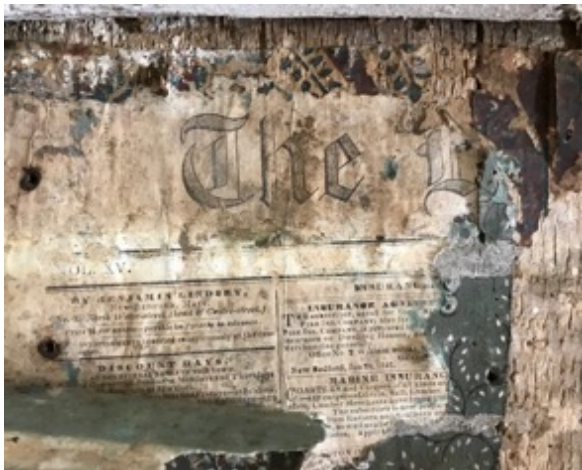
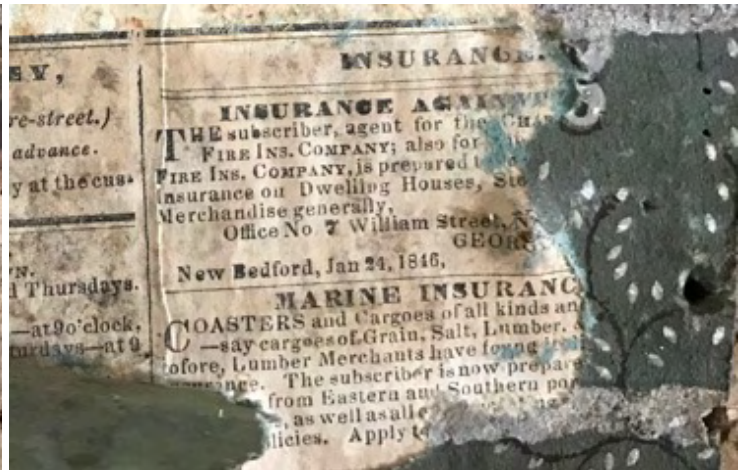
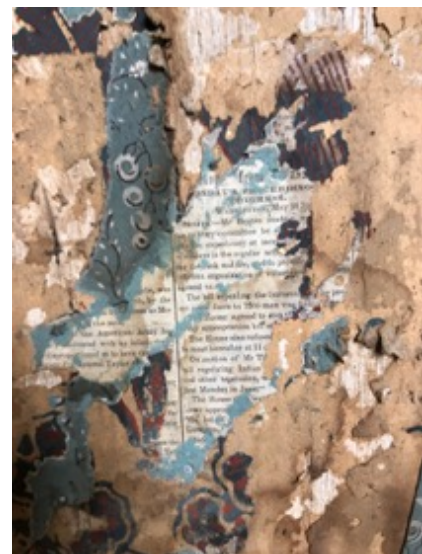
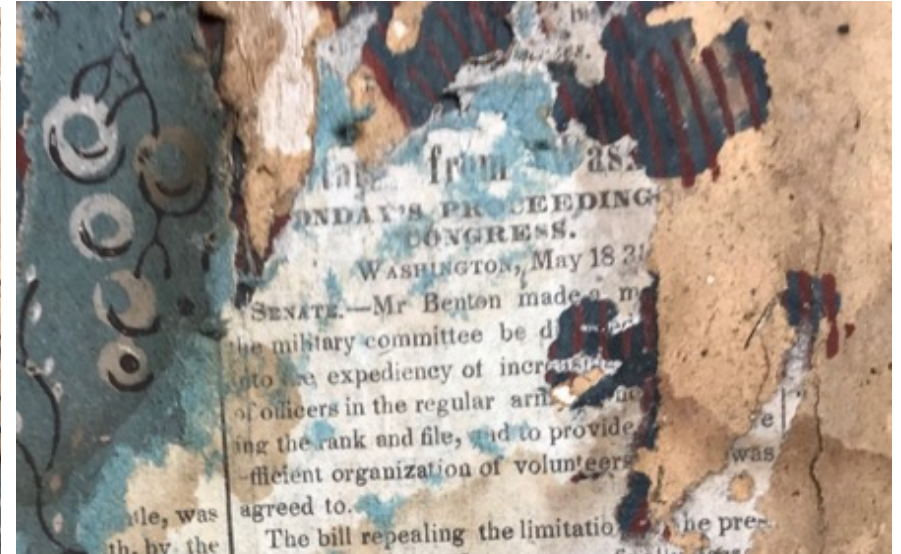
gently humidified and released to reveal the text below. Those areas are shown in the photographs below. Text reads "New Bedford, Jan 24, 1846" and Washington May, 18 31."

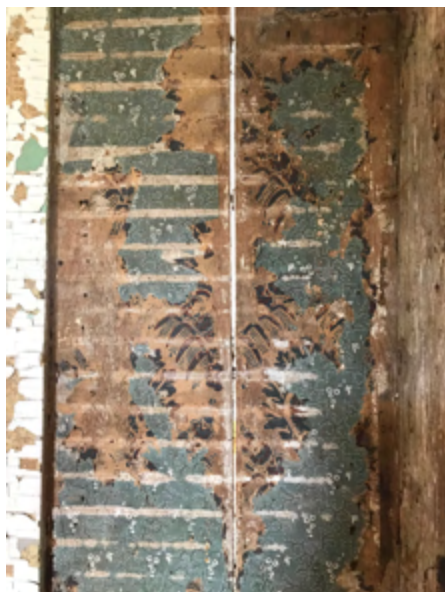
Representative wall section

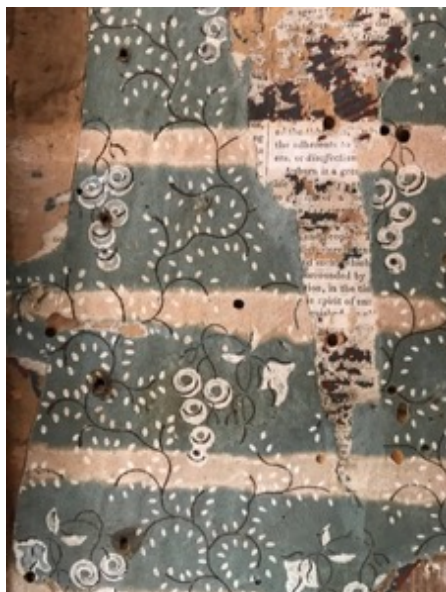
Extant wallpaper fragment

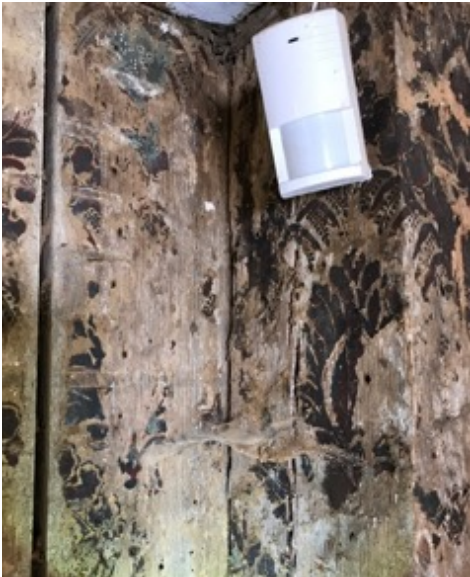
The wallpaper layers exhibit extensive insect activity. Most damaging is the lacing effect on the paper around the design caused by the feeding of silverfish on the cellulose of the paper and the adhesive paste used for installation. Other insect activity is evidenced by the presence of webbing and egg casings throughout the room and on the wallpaper surface.

Insect webbing and frass

Minimal intervention was undertaken with the goal to stabilize and preserve the existing wallpaper in situ. The wall surfaces were vacuumed with a variable suction HEPA-filtered vacuum to remove a heavy accumulation of insect webbing and frass, dust and fine construction debris. The wallpaper was then surface cleaned as possible with extruded latex fire recovery sponges to remove lightly affixed surface dust and dirt. Lifting wallpaper fragments were set down with precipitated wheat starch paste, Jin Shofu manufactured by Nakamura Co., Japan. The wheat starch is purified through precipitation to remove the insoluble glutamine in the starch which contributes to embrittlement and yellowing upon aging, thus producing a very smooth, water-soluble paste with a neutral pH with excellent aging properties. The wheat starch paste was applied very dry to the wood plank surface or the reverse of the wallpaper, as necessary, and dried with a tacking iron over hollytex or hairdryer to ensure fast drying and good adhesion without staining.

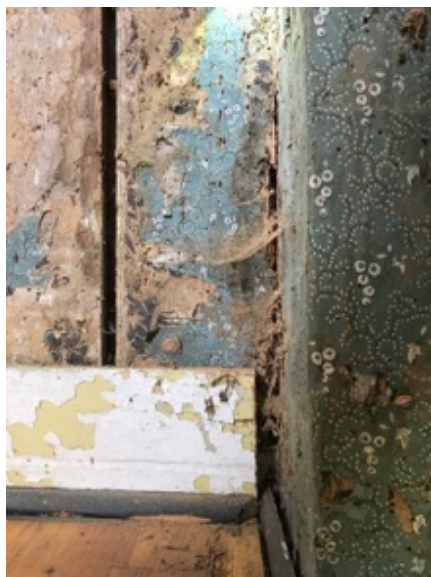
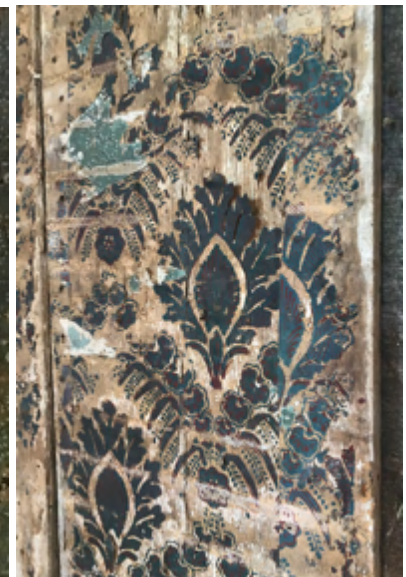
Silverfish damage

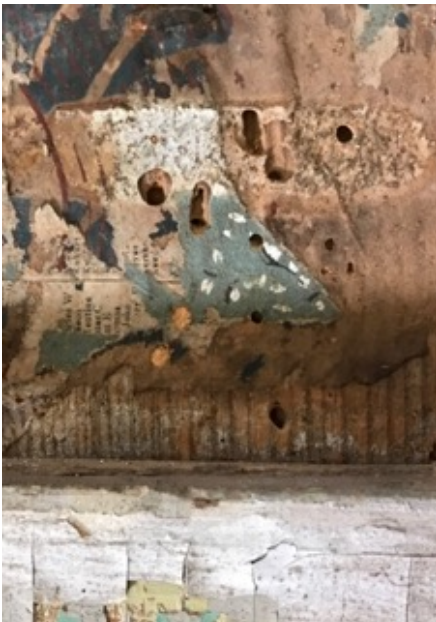
Detachment from the wood resulted from fluctuations in temperature and relative humidity, mechanical damage, as well as destruction of the underlying wall structure by softening and deterioration of the wood as well as the incidental activity of wood borers. The wood borers surfaced from beneath the paper resulting in small circular holes with clean edges. It is noteworthy that the woodboring insects often did not ingest the wallpaper, but remained below the wallpaper surface feeding only on the wood structure. This is distinct from the grazing insects that fed on the surface wallpaper and adhesive.

Wood boring insect damage

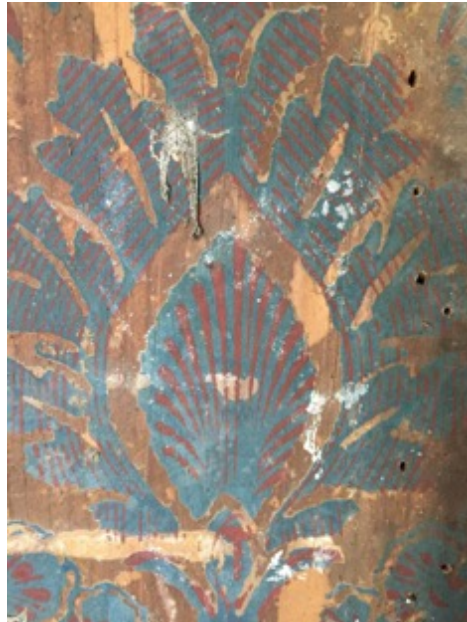
Silverfish damage, general surface accretions

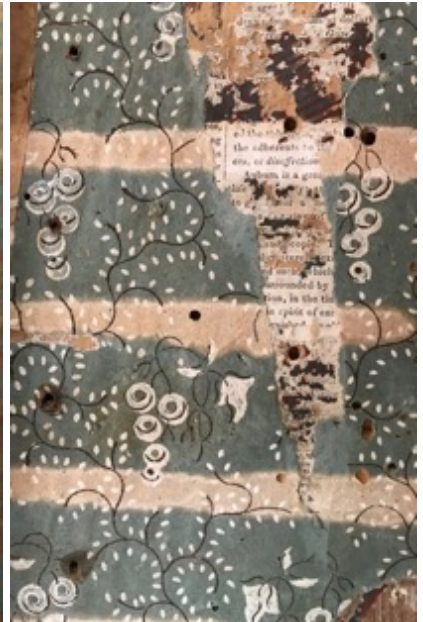
The fading or bleaching of the colorants in horizontal striations are a result of contact with the lime-based plaster between the lath of the surface wall.

Fading of color due to contact with highly alkaline plaster

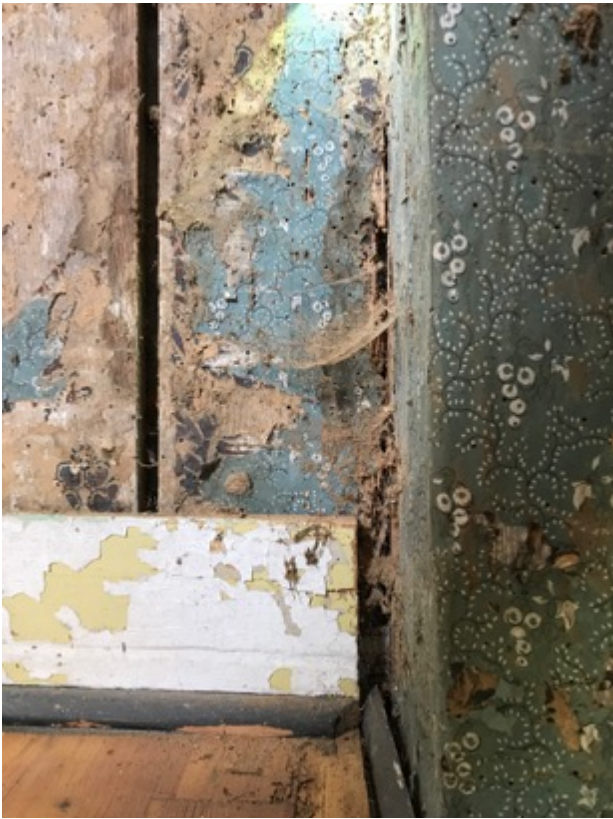
Before surface cleaning

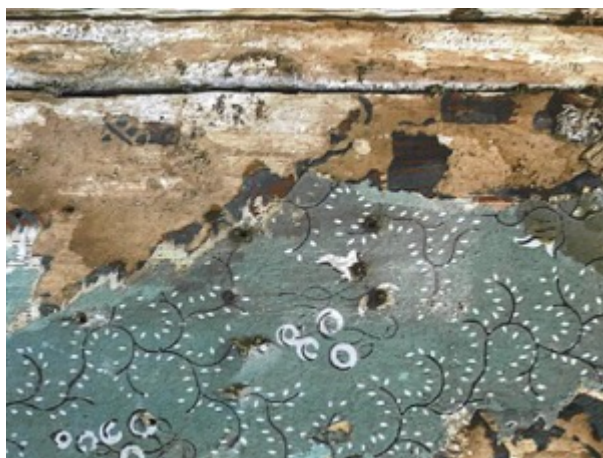
Fig. 1. Detail of wallpaper, showing the upper layer and some of the underlying lower layer.

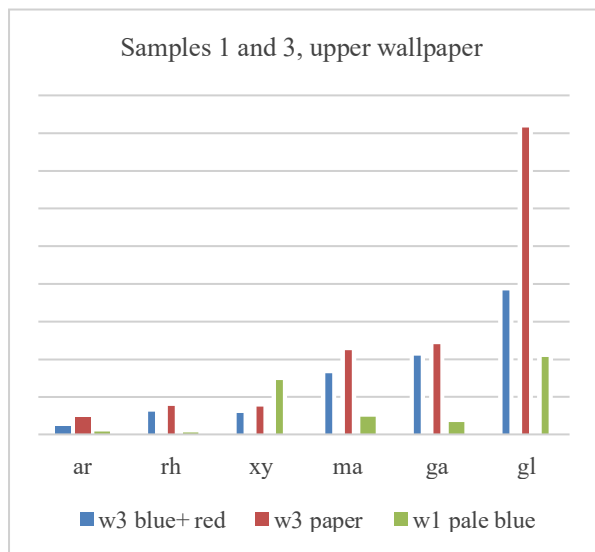
Fig. 4. Comparison of peak areas from six monosaccharides in samples 1 (upper wallpaper: light blue paint with paper substrate) and sample 3 (upper wallpaper: light blue paint and dark red overlying decoration, with paper substrate). Also shown are results from a portion of sample 3 that contained no visible blue or red paint.

Note that the paint-free part of sample 3 (red bars) contains more glucose than the paint-containing portion of the same sample (blue bars) relative to the other five sugars. The elevated level could be due to cellulose. The relative levels of the other five sugars are similar in both portions of sample 3. In sample 1, consisting of the very thin light blue paint on paper, xylose and glucose were the major monosaccharides detected. These two sugars are most likely to be associated with hemicellulose and possibly cellulose rather than a plant gum.

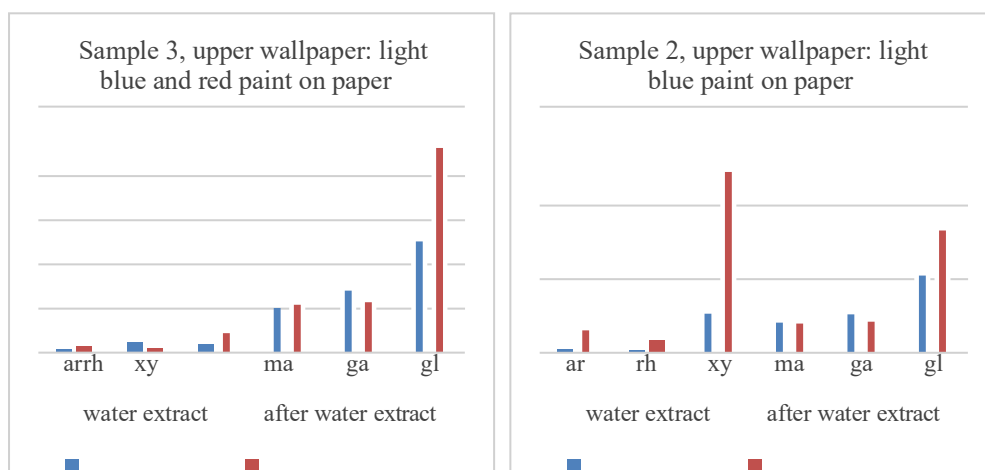
Fig. 5. Comparisons of peak areas from six monosaccharides in water extracts and residual solid portions from sample 2 (upper wallpaper: light blue with paper substrate) and sample 3 (upper wallpaper: light blue paint and dark red overlying decoration with paper substrate). Xylose and glucose are notably present at higher relative levels in the sample 2 residual solid than in the water extract of the same sample. In contrast, only glucose is present at a higher relative level in the sample 3 residual solid than in the water extract of that sample.

Gum arabic contains substantial amounts of arabinose, rhamnose and galactose. These three can also be present in hemicelluloses, so their detection in the wallpaper samples is not indicative of the presence of that plant gum. Monosaccharide profiles of other common plant gums cannot be discerned in the samples either.
