The 1762 Akin House Photo Report of the Cellar Water/Moisture Mitigation Project CPA Project Grant Agreement: 2025-10-01

Prepared by Diane Gilbert, President, DHPT, April 28, 2026, revised May 3, 2026.

The 1762 Akin House: photos of the water/moisture mitigation project.

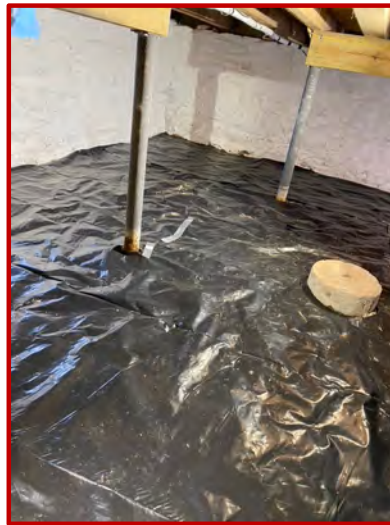
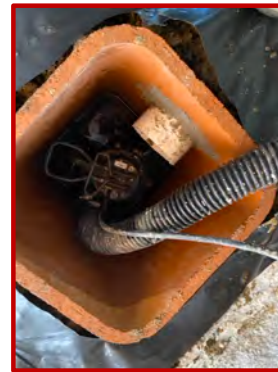
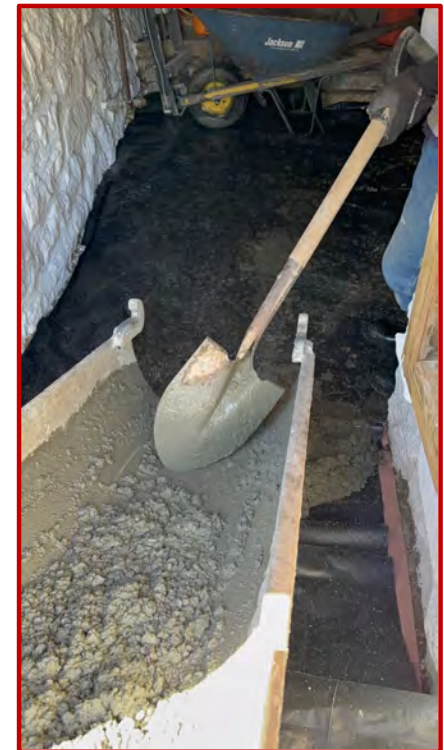
April 9, 2026: Following the installation of the French Drain and the application of several coats of Masonry Sealer, the cellar is prepped for the cement floor on top of a new vapor barrier, which will also cover the French Drain at the perimeter

Far left: The vapor barrier surrounding the center chimney foundation is protected from splatter during the project steps. The very old electric wire at the far center of the photo is "dead" and will be removed. Second from left: Photo shows two supporting steel columns and a cement sphere to remain in situ. Second from right: A terra cotta repository to accept and redirect water from the French Drain system to the sump pump. Far right: Cement pour.

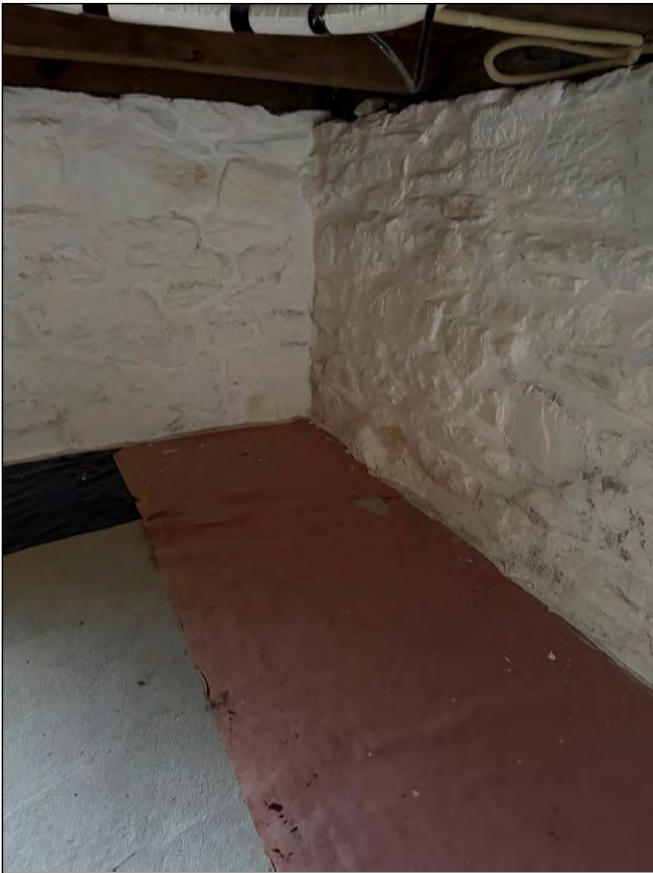
Project completion photos.

Left: Northeast corner of the cellar.

Right: Northwest corner of the cellar.

Note: The terminated pipe is a water source from Dartmouth Street to the cellar.

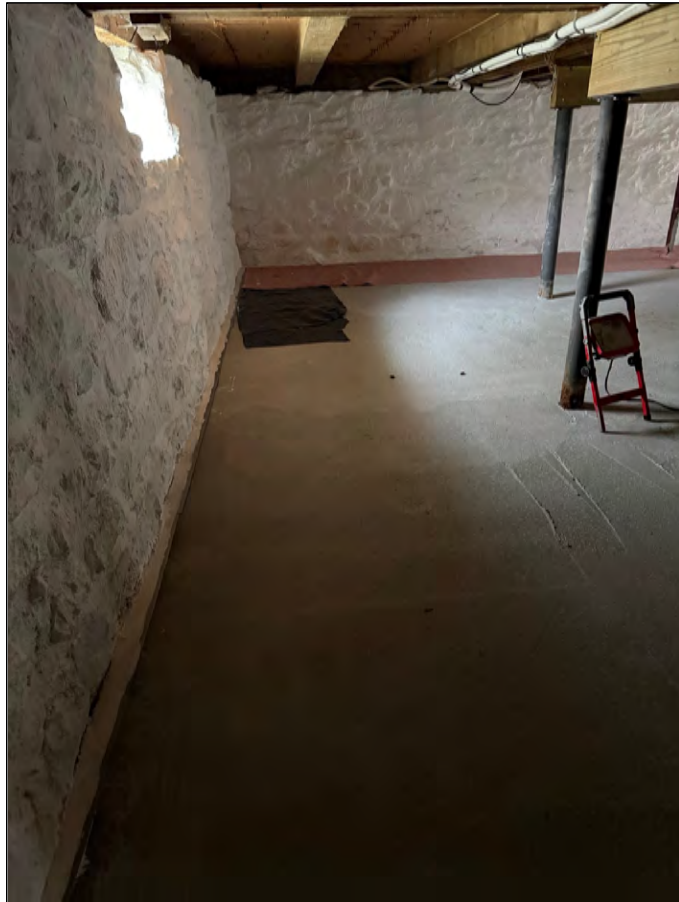
Left and right: Views of the northeast corner of the cellar.

Left: Steel columns installed on cement pads below ground to support new beams during Phase 2 of conservation work.

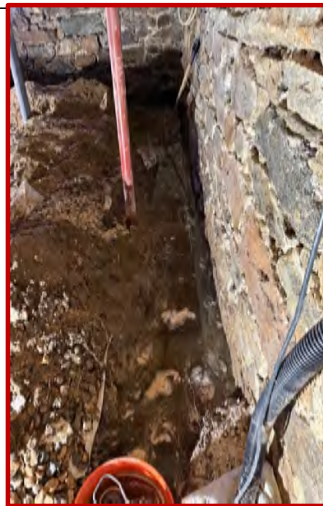
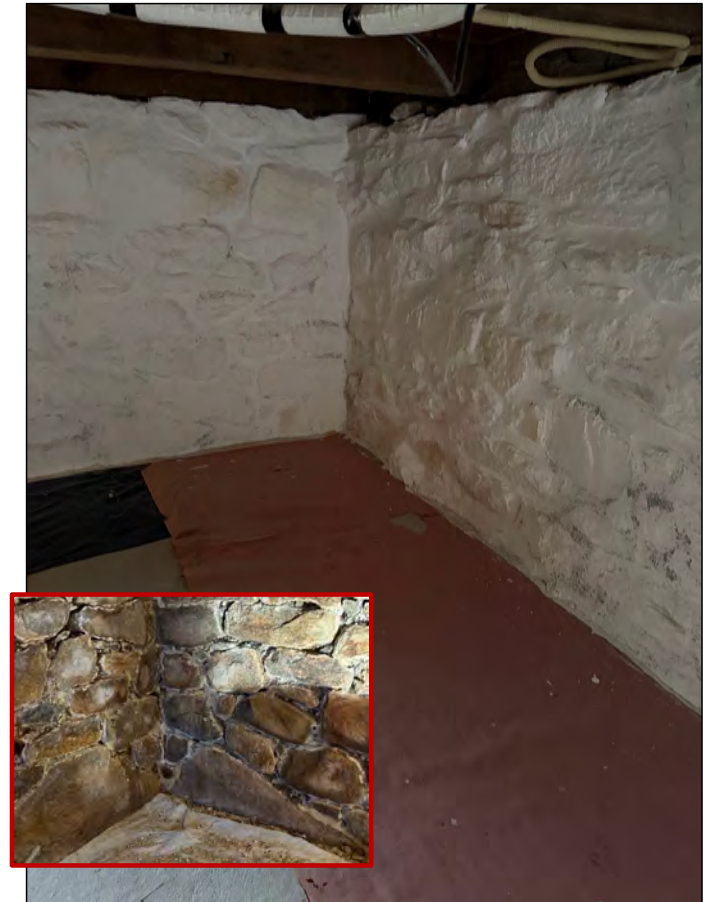
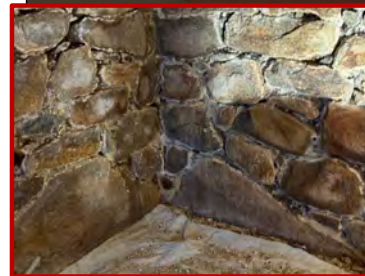
Below: "Before" photos as the work commenced

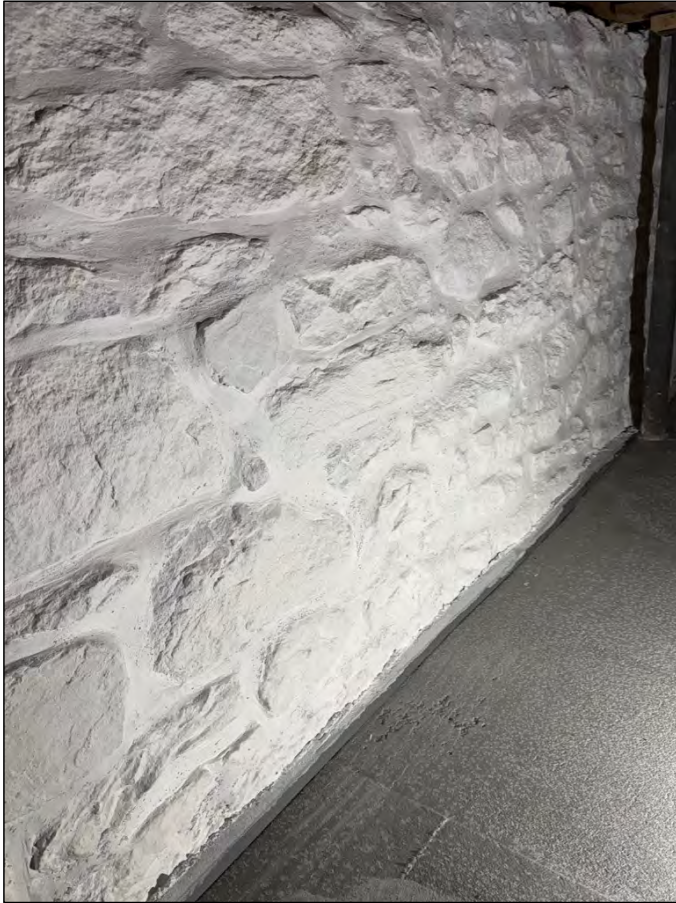
Left: White masonry sealer with several coats applied.

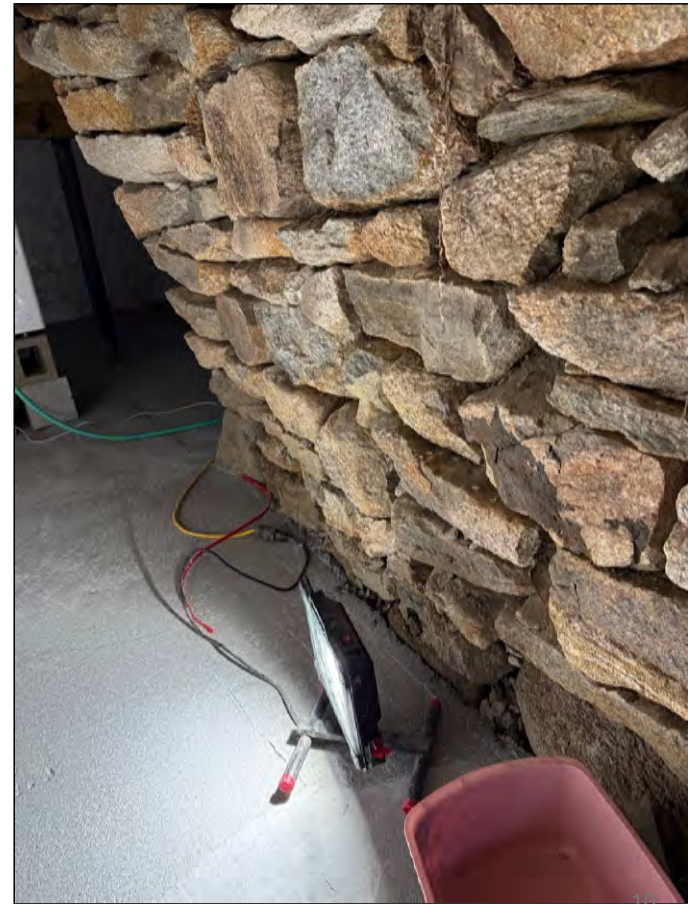
Right: A view of the cantilevered style chimney foundation facing the west side of the cellar. An impressive structure of structural beauty, integrity, and longevity.

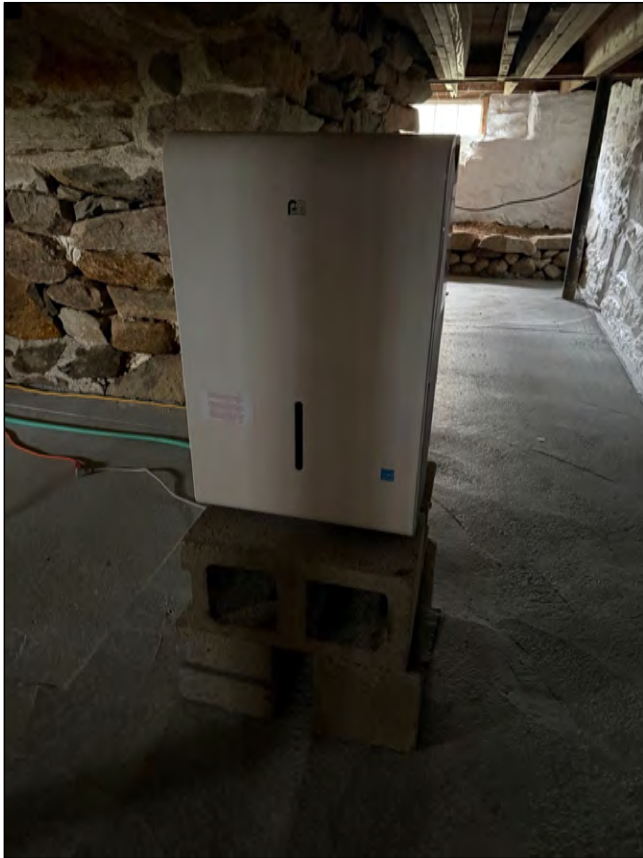
Left: Dehumidifier placed near the north west corner of the cellar.

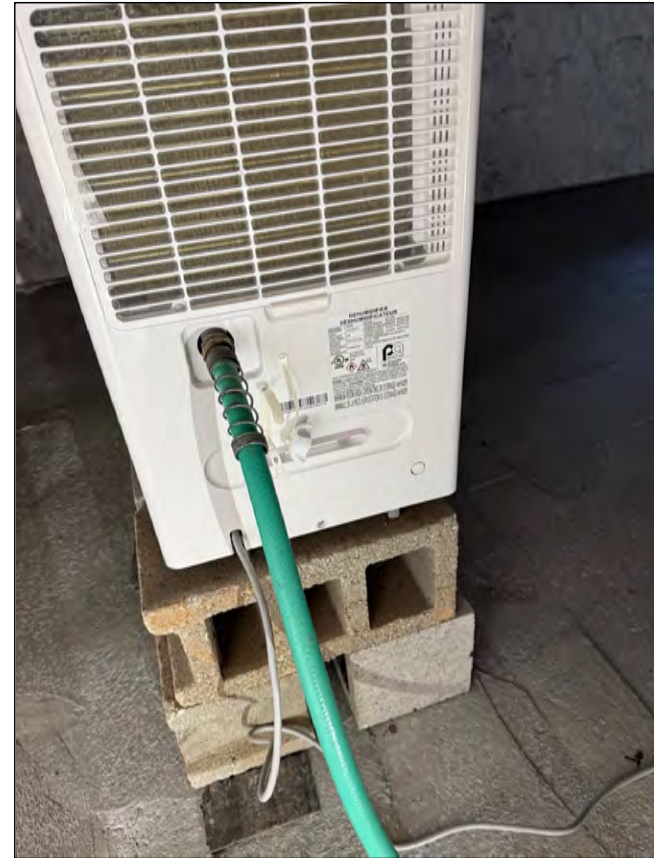
Right: Rear view of the dehumidifier.

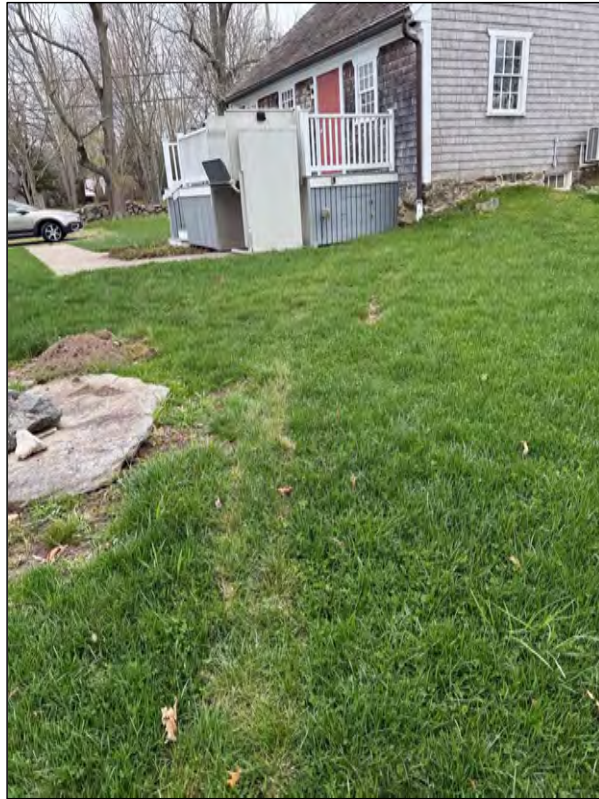
Left: View from the back deck showing the location of the hose planted below grass level, from the cellar away from the house.

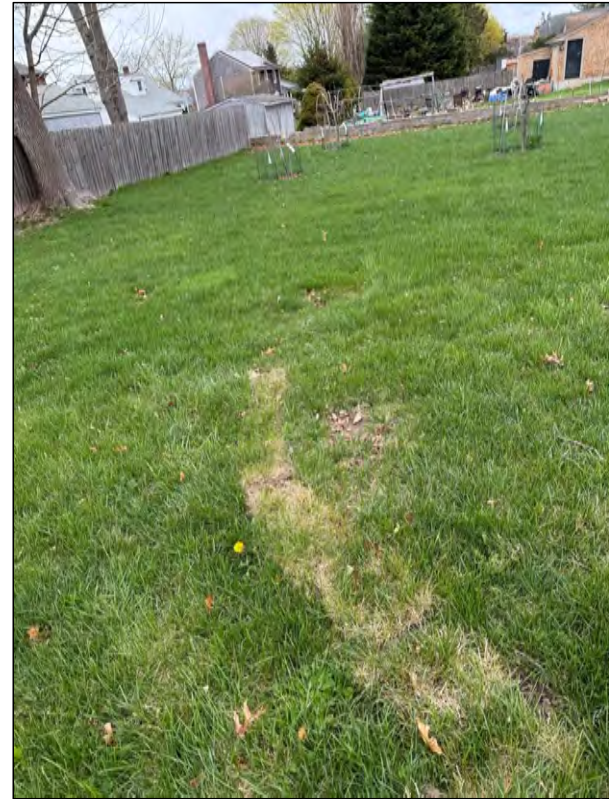
Right: View from the house, showing the direction of the hose planted below grass level toward the rear landscape. Heritage 18th C. apple trees in the distance.

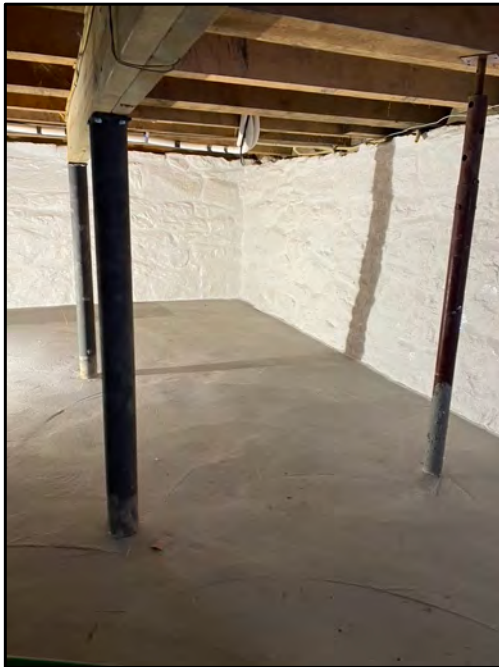
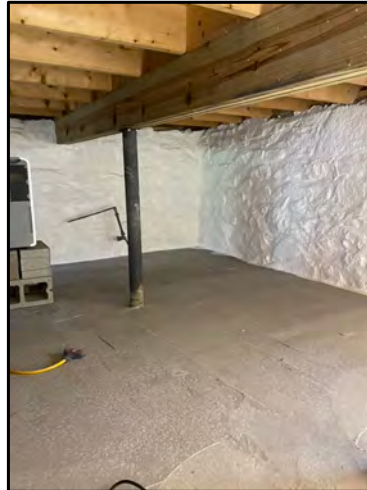
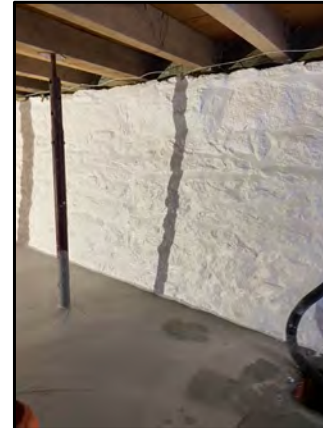
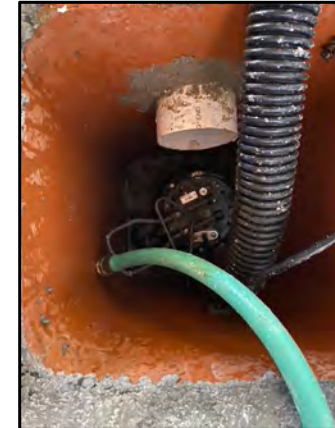
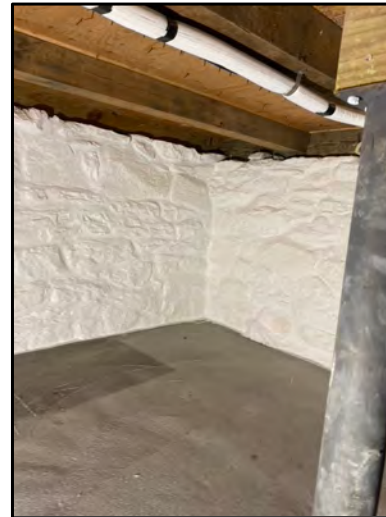
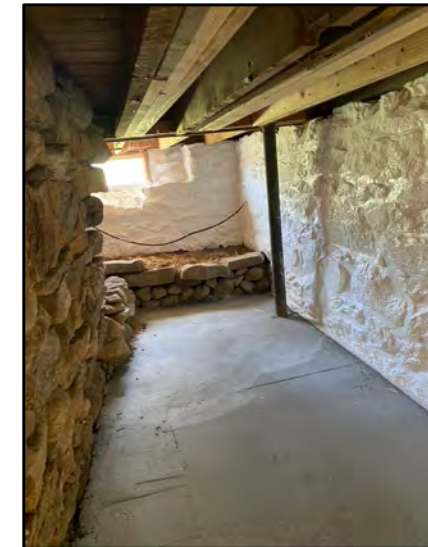
Photos taken on April 29, 2026 after the final coat application of the masonry sealer and cleanup. The Akin House cellar is very happy!
